## Magnetic Filtration Case Study

## Marion Dragline

BMA Open Cut Coal Mine  
Queensland, Australia

**APPLICATION:** No. 2 Gear Box  
DRE 38 Drag Line

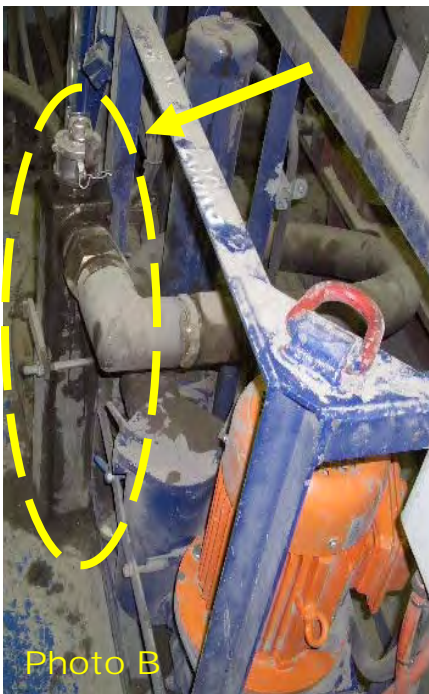
**SOLUTION:** Install an OEI Magnetic Scrubber (5SC24SCL) to the existing kidney loop filtration system (see Photo B)

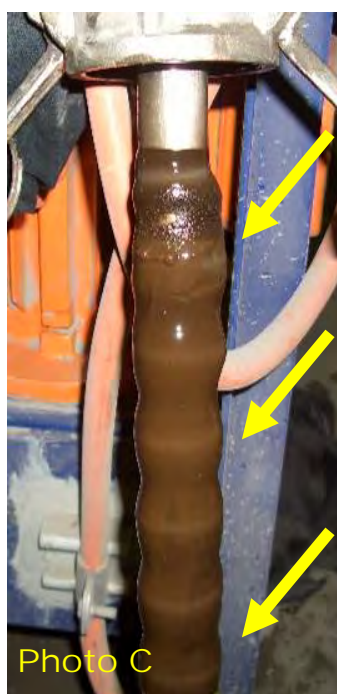
**RESULTS:** After three days of operation, the OEI magnetic filter was removed revealing a significant amount of ferrous contamination that had been extracted from the gear oil (see Photo C). Laboratory report showed a sizeable reduction in Particle Quantity count from 3904 to 723.

Tim Rantin (Flac Champion) of BMA mines concluded the contaminants removed by the OEI Magnetic Filter are particles the existing filtration system was unable to capture. These particles will prematurely wear out the gear box components and seals in addition to degrading the fluid.
