## CASE STUDY

SHOVEL GEAR BOX

LUBE OIL

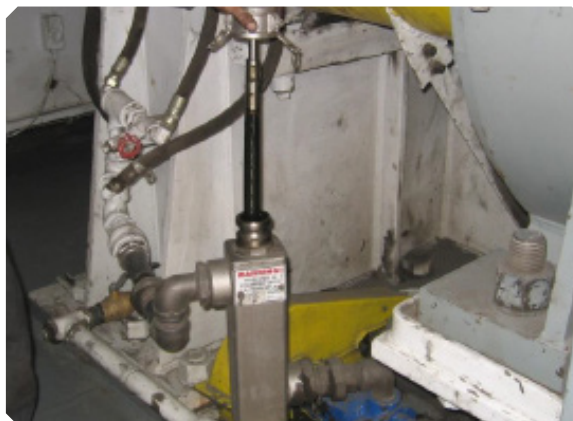
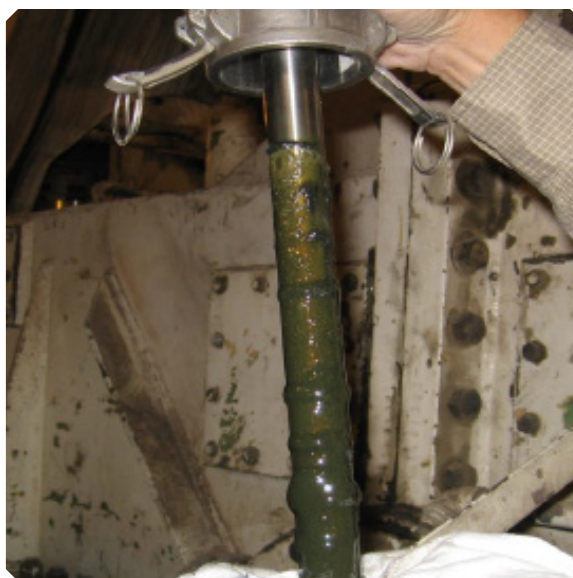
After hours a substantial amount of ferrous contamination was trapped on the OEI magnetic filter. The OEI Scrubber is installed on the suction side of the pump.

If left in the fluid, these ferrous particles will prematurely wear the transmission components and degrade the fluid viscosity.

Install an OEI magnetic filter scrubber.
