Magnetic Filtration Case Study

Calfrac(Previously Frac Source) Coil Tube Service Truck Red Deer, Alberta

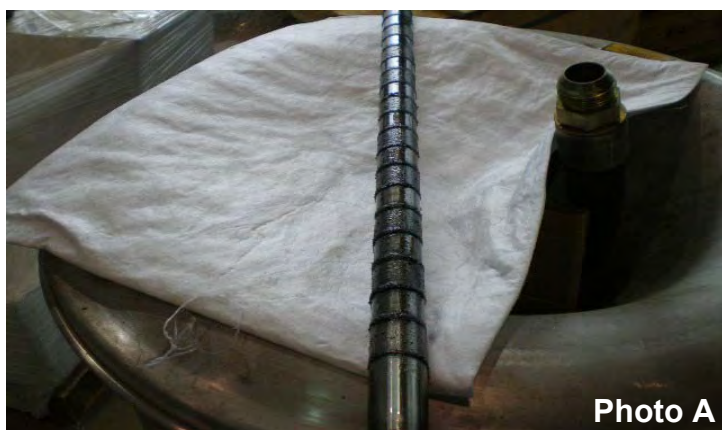
RESULTS: The magnetic filter rod was installed for warranty protection when the truck was built for Calfrac. The senior design engineer Oleg Tsvik was so impressed he assigned the OEI filter as an OEM part. Photo A was taken after 20 months in the field. The Calfrac maintenance manager Colin Penz observed this significant amount of ferrous metal and stated **"it sure shows what traditional filters miss", if the metal was left in the system we may have lost a pump, not to mention seals"**.

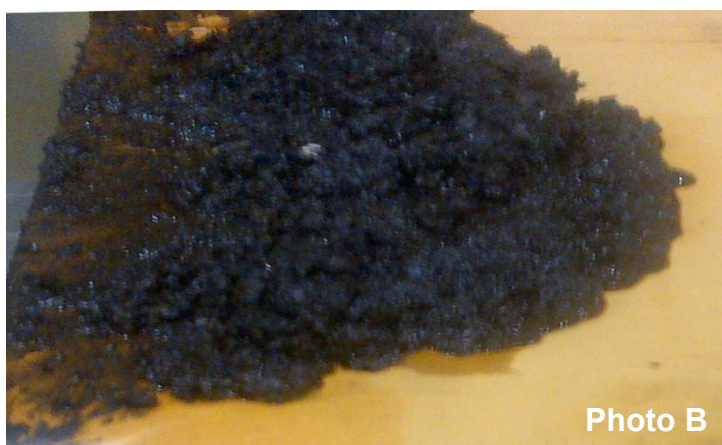
Photo B

The hydraulic system, pumps, and seals have been protected from failure and the system has operated without downtime since the installation of OEI's magnetic filtration technology in 2007. Photo B, taken in May 2013, shows the contamination collected on the rod since its last PM period.
