CASE STUDY

M/Y ALTAIR III

1974 TRANSOCEANIC LUXURY YACHT ENGINE

ENGINE OIL

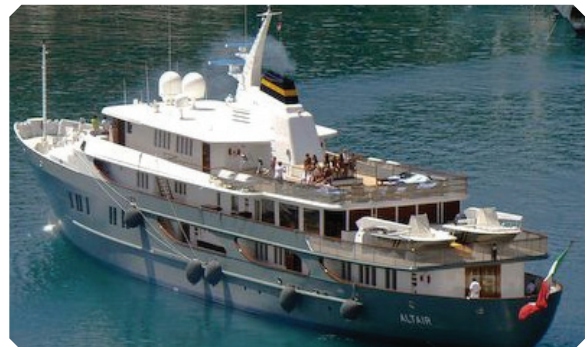
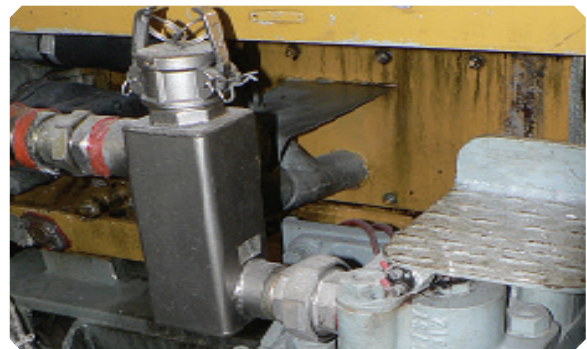
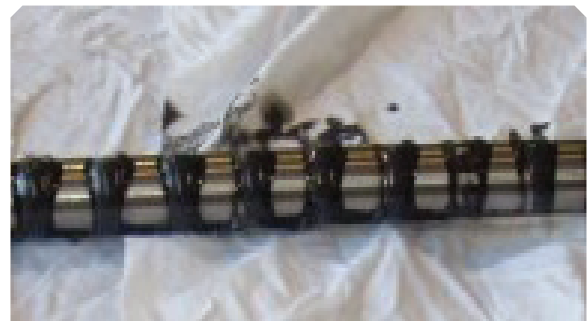
The photo shows contamination collected on the magnetic filter element after 200 hours of operation. The oil was effectively cleaned to improve engine reliability.

Install an OEI filter scrubber on the engine oil line.
