CASE STUDY

M/Y ALTAIR III

194 TRANSOCEANIC LUXURY YACHT 1974 AMELS

PRODUCT
RECOMMENDATION
ADD-VANTAGE 9000

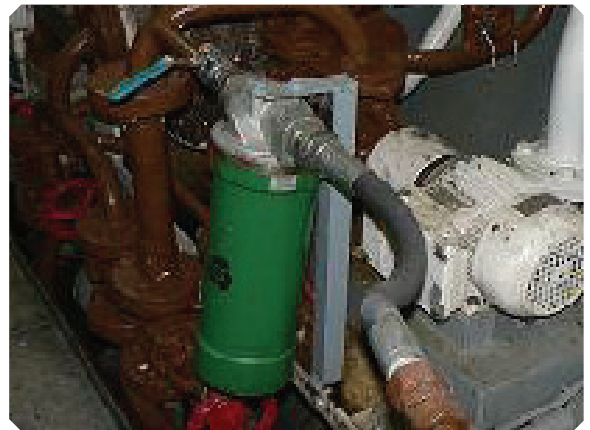
The ferrous metal trapped on the magnetic filter shown in the photo represents 500 hrs of running time. This metal dust along with sludge is common of diesel fuel and water. If left in the fuel these metal particles will prematurely wear the injectors and fuel pump.

Capture wear contamination missed by the luxury vessel's existing filtration system and prevent it from prematurely wearing on fuel system components. The source of this contamination is the corrosion of transmission lines that carry the fuel to the end user.

Install an OEI ADD-Vantage 9000 after the fuel centrifuge system.
