## CASE STUDY

M/Y DREAM WALKER

64' LUXURY VESSEL

FUEL

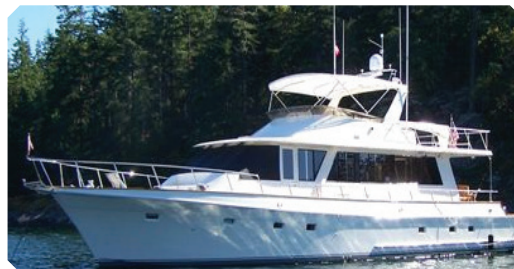
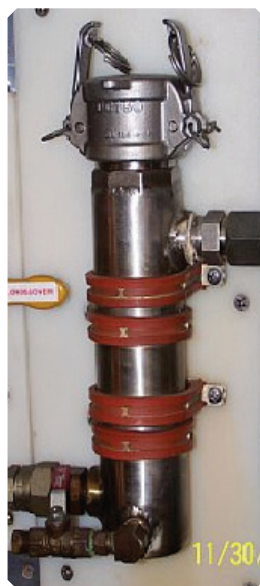
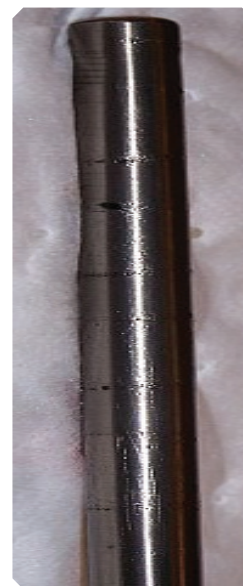
The image shows contamination removed from the fuel after 500 hours of operation. The contamination captured on the magnetic filter element is an accumulation of iron particles below 4 microns; if left in the system these iron particles would damage the injectors and pump.
