CASE STUDY

TAMINCO N.V.

MAGNETIC DRIVE PUMP

CORROSIVE & HIGHLY TOXIC LIQUID

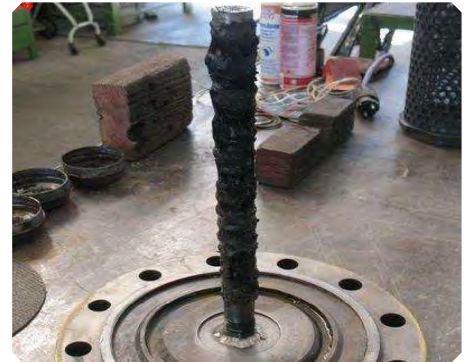
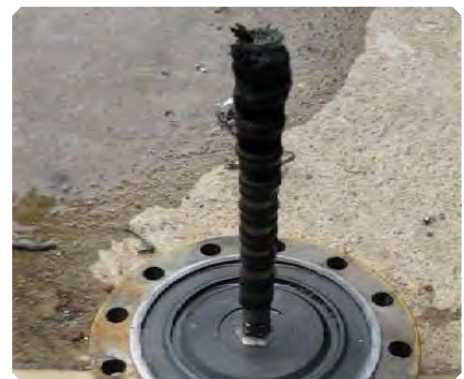
The picture shows contamination captured after 2 weeks of deployment. After 1 month of operation, all pumps were operating at full efficiency with no failures to report.

APSICON the Netherland distributor for OEI recommended installing OEI magnetic filter elements into strainers on the suction side of pump in order to capture contaminatoin down to sub-micron and below.

After experiencing these results, Taminco instated an inspection schedule whereby the magnetic filter elements would be inspected first after 2 weeks, then the following inspection would be extended to 4 weeks, and then inspections would take place every 6 weeks.
