CASE STUDY

BURLINGTON RESOURCES

COOLANT PUMP

**MAGNETIC FILTER
Y-STRAINER**

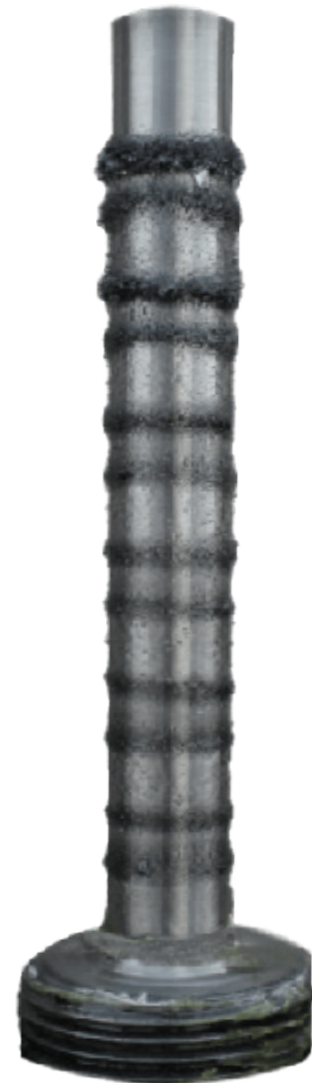
Install an OEI magnetic filter y-strainer on the suction side of the diaphragm pump.

The magnetic y-strainer successfully filtered the wear contamination down to 4 microns and below.
