CASE STUDY

SACMI GROUP

MILLING MACHINE

CAPTURED
WEAR
CONTAMINATION
MISSED
BY OEM FILTERS

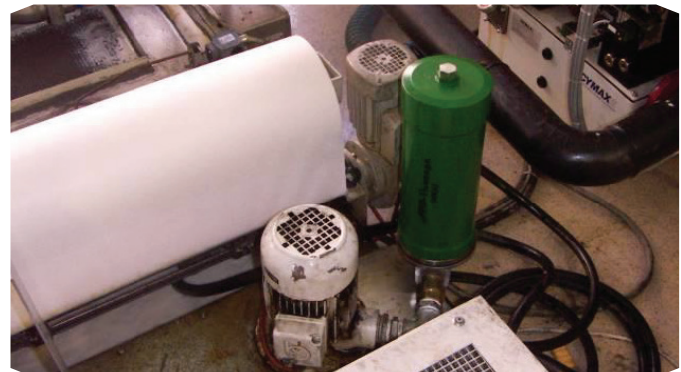
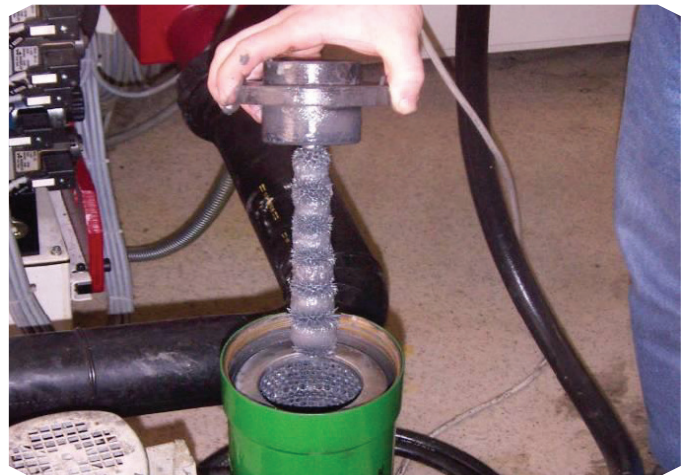
The photo on the right show contamination captured on the magnetic filter element after 1 week of deployment. Installing the ADD-Vantage 9000 downstream of the OEM filters proved that the magnetic filter captured a considerable amount of ferrous contamination was missed by the first two-filtration systems.

The oil is filtered twice before reaching the ADD-Vantage 9000. It is first passes over an OEM's magnetic drum to remove the large particles. Next, the oil is flooded onto a large paper roll that should filter to 40 microns. It then passes through the ADD-Vantage 9000.
