CASE STUDY

CALFRAC

COIL TUBE UNIT HYDRAULIC RESERVOIR

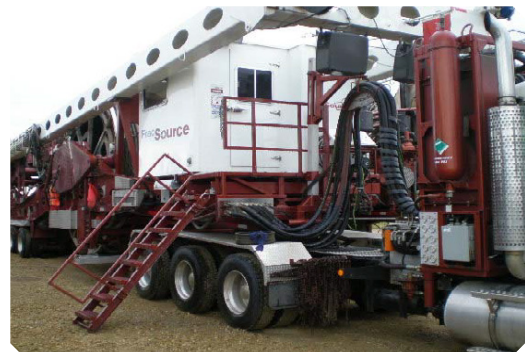
Ferrous contamination during pre-commissioning test of new equipment.

Install an OEI magnetic filter element in the hydraulic reservoir. The removal of this contamination down to submicron level will extend hydraulic fluid and component life and increase system reliability.

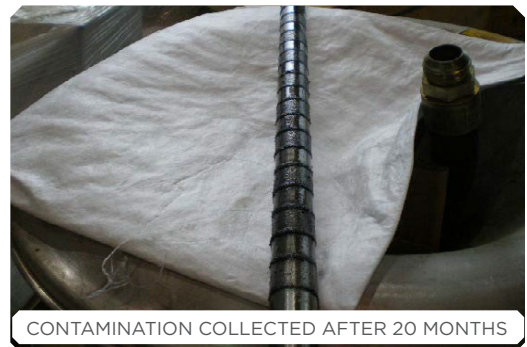
CONTAMINATION COLLECTED AFTER 20 MONTHS

The magnetic filter rod was installed for warranty protection when the truck was built for Calfrac. The senior design engineer was so impressed he assigned the OEI filter as an OEM part. The second photo was taken after 20 months in the field.

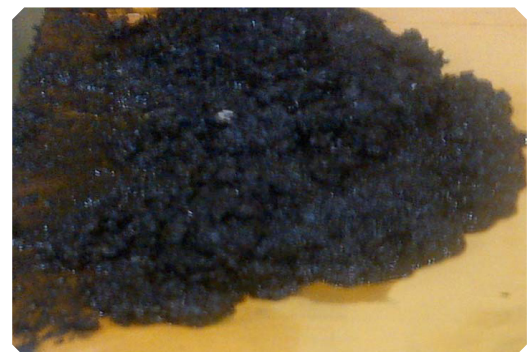
The hydraulic system, pumps, and seals have been protected from failure and the system has operated without downtime since the installation of OEI's magnetic filtration technology in 2007. The third photo, taken in May 2013, shows the contamination collected on the rod since its last PM period.
