## CASE STUDY

COAL COMPANY

HYDRAULIC FILTER CART

**MAGNETIC  
FILTER SCRUBBER**

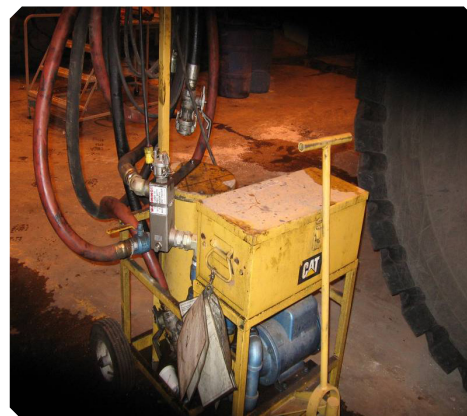
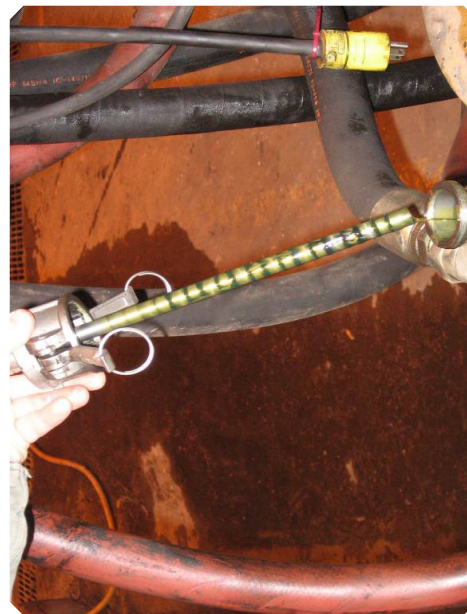
The magnetic filter has extracted a considerable amount of contaminants as shown on the photo at the right. Removal of these contaminants will prevent premature wear to the components and extend fluid life.

Install an OEI magnetic filter scrubber on the suction side of this filter cart prior to the pump and filter. The scrubber is equipped with OEI's patented magnetic filter.
