CASE STUDY

CONSOL ENERGY, BAILEY MINE

13-H LW EMULSION SYSTEM

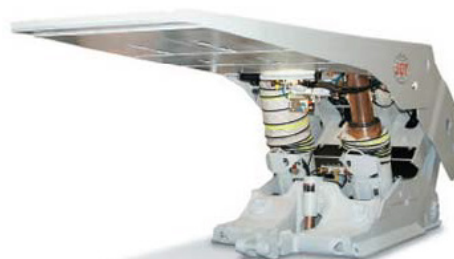
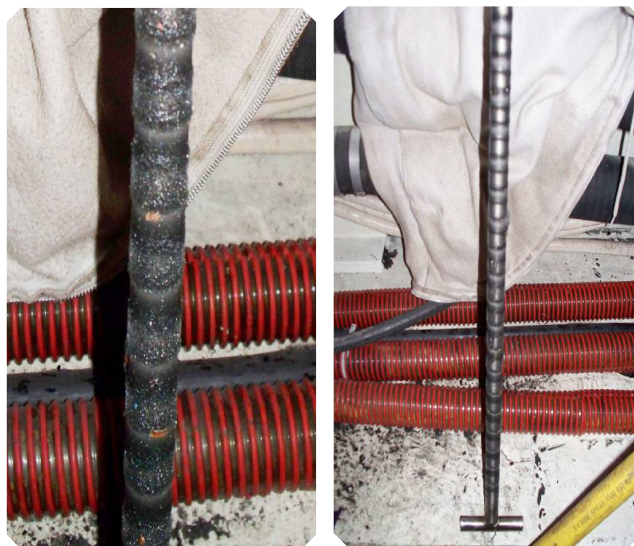
The adjacent photos show the amount of ferrous and non ferrous contamination trapped on the magnetic filter rod after only 4 days of operations. Removal of this contamination will extend the components life, reduce emulsion loss and increase up-time.

Install OEI magnetic filter elements inside the disposable return line filters (inside/out flow) that will filter down both ferrous and non ferrous contamination to submicron levels and significantly reduce the worm holing and channeling.
