CASE STUDY

HOMAX OIL COMPANY

FILLING STATION PUMP

ADD-VANTAGE 9000

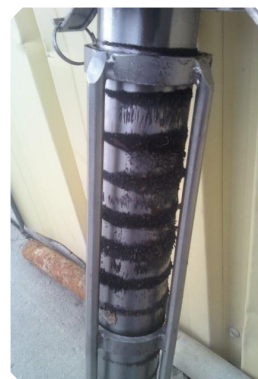
A photo on the top right shows an installation prior to the filling station pump. The oil has been filtered by 6 micron filters before delivering to the customers in the past. Since the addition of the OEI scrubber to the filtering system, customers have noticed an increase in ISO cleanliness to their oils.

A photo on the bottom right shows the results of a new pipe line installation for unloading rail cars. An OEI scrubber was installed prior to the filtration system and the line was flushed with diesel fuel.
