CASE STUDY

INTERQUISA PTA PLANT

DRUM ROLLERS

T.A. DRYER

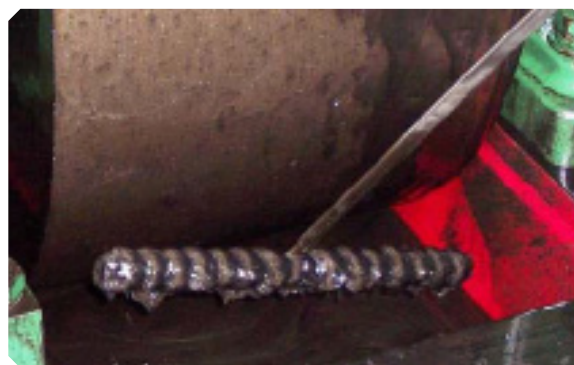
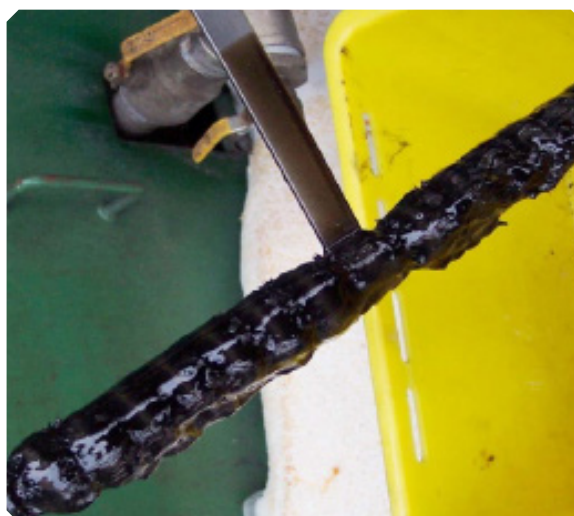
Metal erosion contamination on the support roller lubrication system. The system did not have a filtration system for the lubrication oil. The contamination caused premature wear of the drums and plugs the oil spray lubrication.

This design showed great results as seen by the adjacent photos. Numerous passes were made to remove all the ferrous contaminants, once cleaned the magnetic filter will be left in the oiling tray to continue cleaning. This magnetic filter will extend the life of the oil and drum roller.

Install an OEI magnetic filter element with a long handle capable of reaching under the support roller in the oiling tray, which would clean the oil to submicron levels.
