CASE STUDY

MEDISYSTEMS EUROPE SPA

INJECTION MOLDING MACHINE

HYDRAULIC OIL

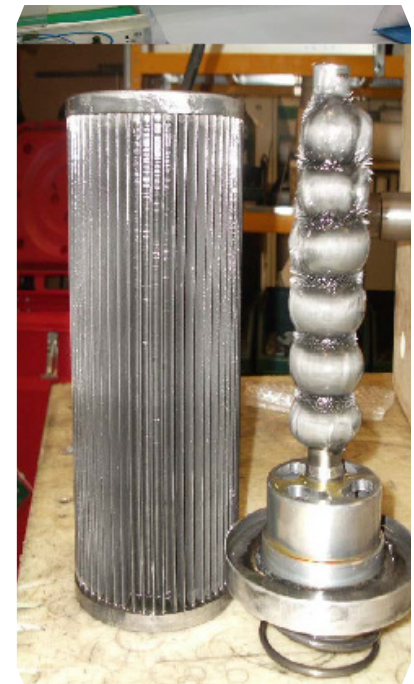
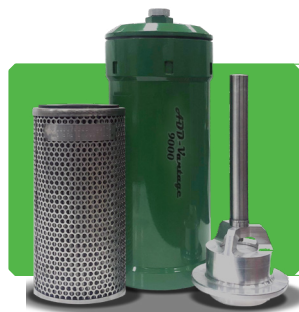
A photo on the right shows a substantial amount of ferrous contamination captured by the ADDVantage 9000's magnetic filter rod after the first system cleaning. These particles are to submicron in size. They were able to complete the production run without shutting down and replacing the pump.

High level of ferrous contamination as a result of premature failing of pump components causing OEM filters to clog once a week resulting in downtime for repairs. To complete the production run they would have to leave the failing pump in service. The OEM filters would not allow them to maintain production because they were unable to remove the large volume of fine wear contamination.
