CASE STUDY

MOUNT POLLEY MINING CORPORATION

WILLIAMS LAKE, BC CANADA / MAY 2010

PINION GEAR LUBE

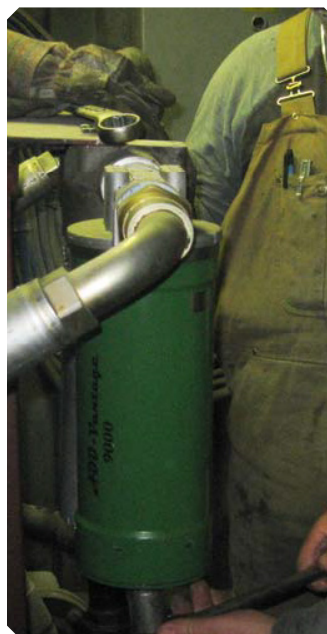
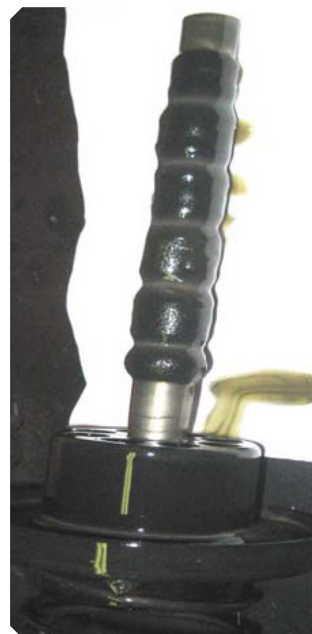
After 7 days, a substantial amount of ferrous contamination was extracted and trapped on the OEI magnetic filter. If left in the fluid these metal particles will prematurely wear the components and reduce the gear oil life.

“ without the One Eye filter a significant proportion of this fine metal would have found its way back to the pinion bearings, gears and lubrication pump. This could have lead to premature failures and costly unplanned maintenance”
