Aerospace Applications

ONE EYE INDUSTRIES

AN ESTABLISHED INNOVATOR IN THE FIELD
OF FLUID FILTRATION

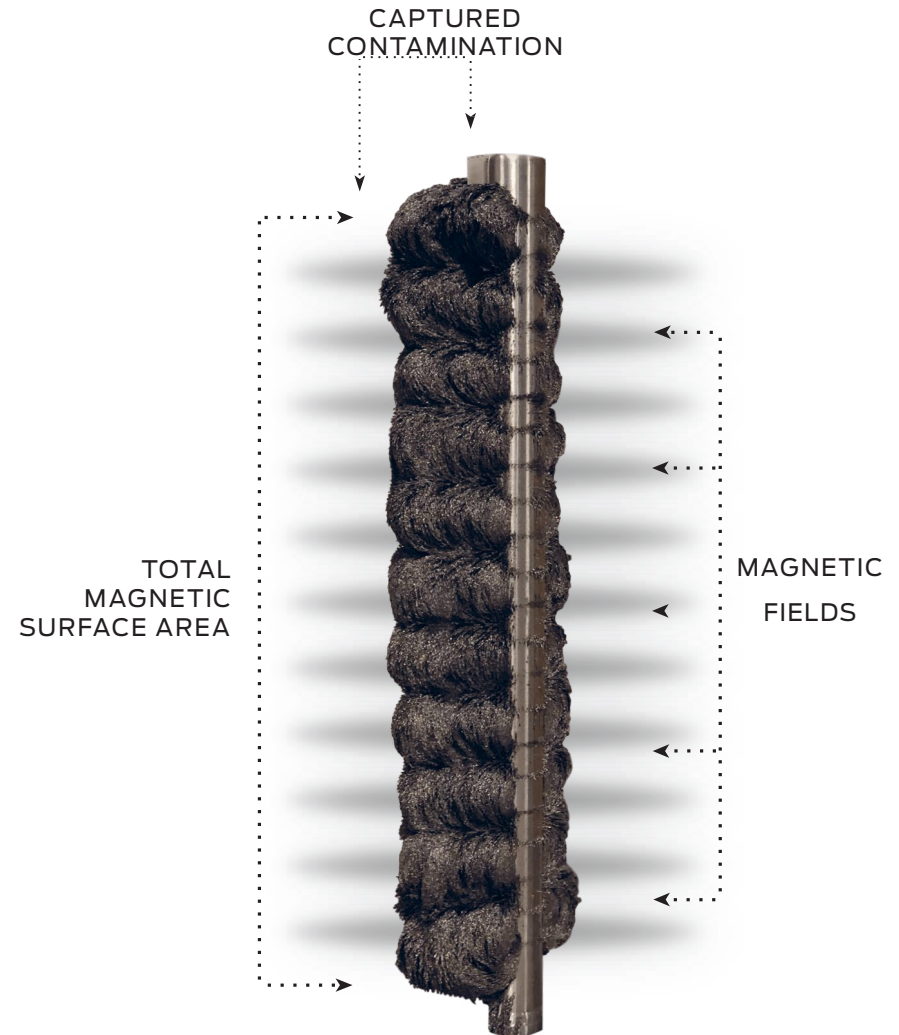
The patented, magnetic filter element attracts ferrous wear particles down to and below 4 microns (μ) with up to 95%+ efficiency.

The magnetic filter element attracts both ferrous and non-ferrous particles.

The radial magnetic field design offers incredible holding strength, and a high dirt holding capacity.

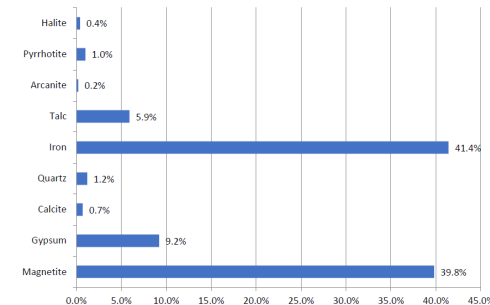
XRD Weight Percentage Bar Graph

Analysis of contamination captured on the magnetic filter element after 8 days of operation showed a decrease in:

91.2% of the contaminants captured were under 4 microns. 45.6% of the contaminants were under 1 micron.

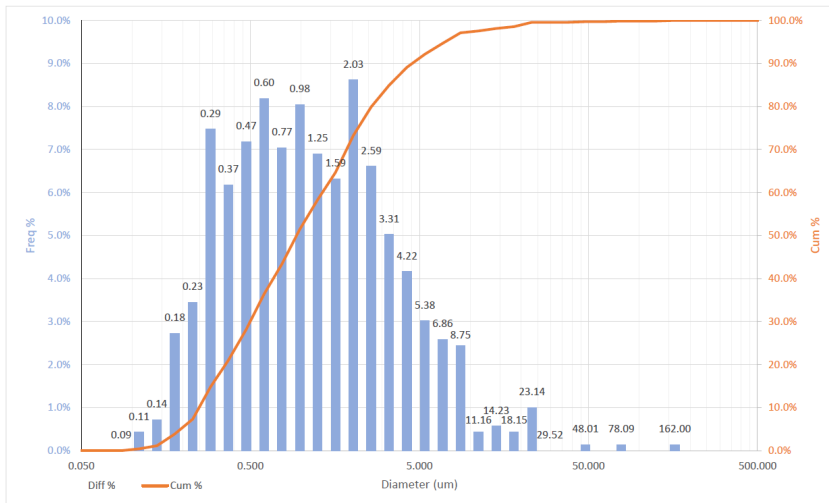
Particle Size Graph

- One paper towel sample was received by SEMx Incorporated for particle size analysis using scanning electron microscopy (SEM).
- The paper wipe samples were put into ultrasonic cleaning to separate the particles from the paper and subsequently filtered to create one analysis sample. A representative portion of each sample was taken for PSD analysis.
- SEM was used to observe and count the particles in the sample to obtain the particle size distribution. Size is measured by length in micrometers. Statistics and analysis is based on total counts measured by SEM. SEM was conducted on a JEOL - JSM300 LV.

- XRD shows majority of particles are iron, iron oxide and silicon oxide. PSD analysis shows majority of particle are in the range between 0.1-9 um.

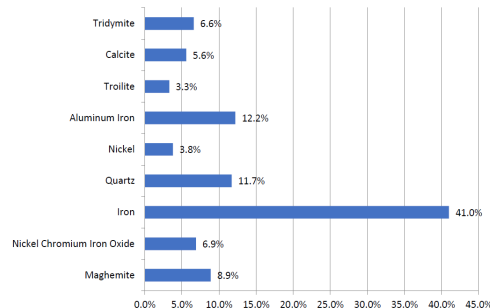
XRD Weight Percentage Bar Graph

Ref. Code	Mineral Name	Compound Name	Chem. Formula	Weight %
00-025-1402	Maghemite	Iron Oxide	Fe ₂ O ₃	8.9
04-017-2616		Nickel Chromium Iron Oxide	Cr ₂ Fe ₁₈ NiO ₄	6.9
04-003-3330	Iron	Iron	Fe	41.0
04-015-7194	Quartz	Silicon Oxide	SiO ₂	11.7
00-060-1502		Cellulose* (from paper towel)	(C ₆ H ₁₀ O ₅) _n	Excluded
04-014-0268		Nickel	Ni	3.8
04-001-2403		Aluminum Iron	Fe ₃ Al	12.2
04-004-7981	Troilite	Iron Sulfide	Fe ₉ S ₈	3.3
04-013-2116	Calcite	Calcium Magnesium Carbonate	Ca _{0.938} Mg _{0.062} (CO ₃)	5.6
01-071-0261	Tridymite	Silicon Oxide	SiO ₂	6.6
