OEI MAGNETIC FILTRATION – CONTAMINATION ANALYSIS CASES

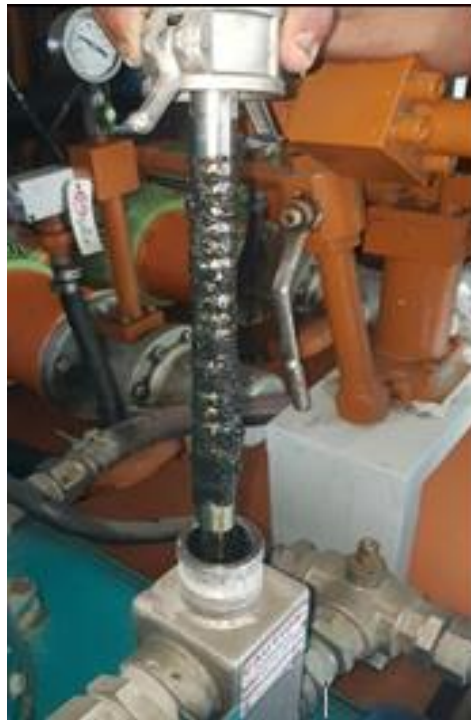
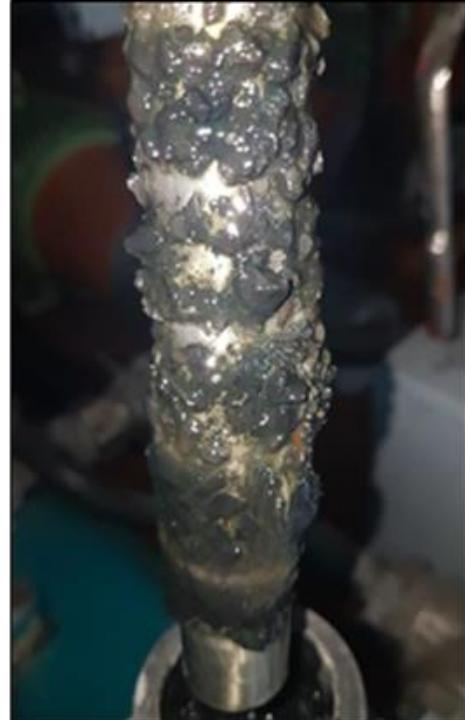
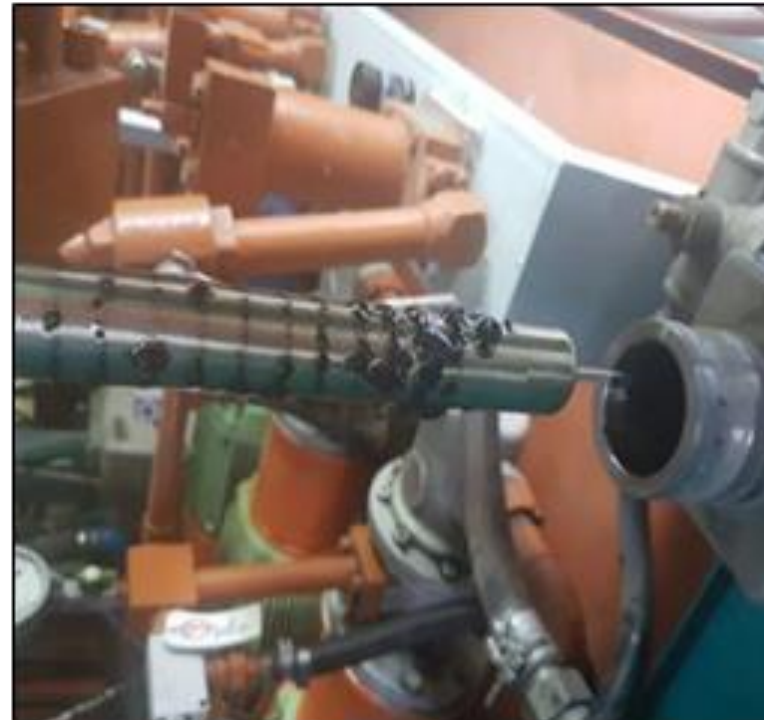
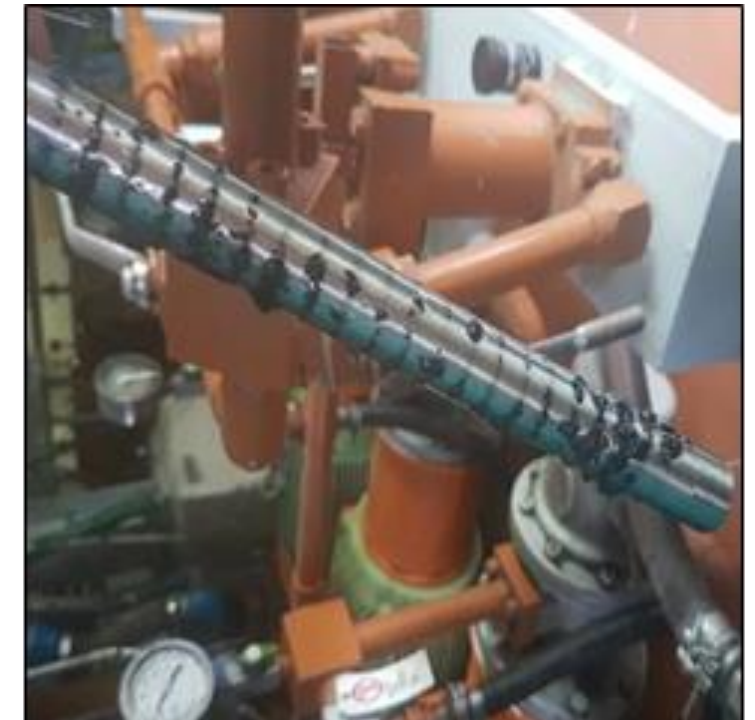
- Contamination captured after 24 hours on the OEI magnetic filter elements

- Photos taken after 5 days on the same rods showing contamination that was trapped, indicating that a significant amount of contamination has been removed from the lubrication system.

The purpose of the magnet is three-fold;

- to capture and trap the contaminants,
- to protect the offline filter pump and extend the life of the filter inserts,
- to act as a condition monitoring tool - The debris can be extracted from the magnetic rod and analysed in the lab.

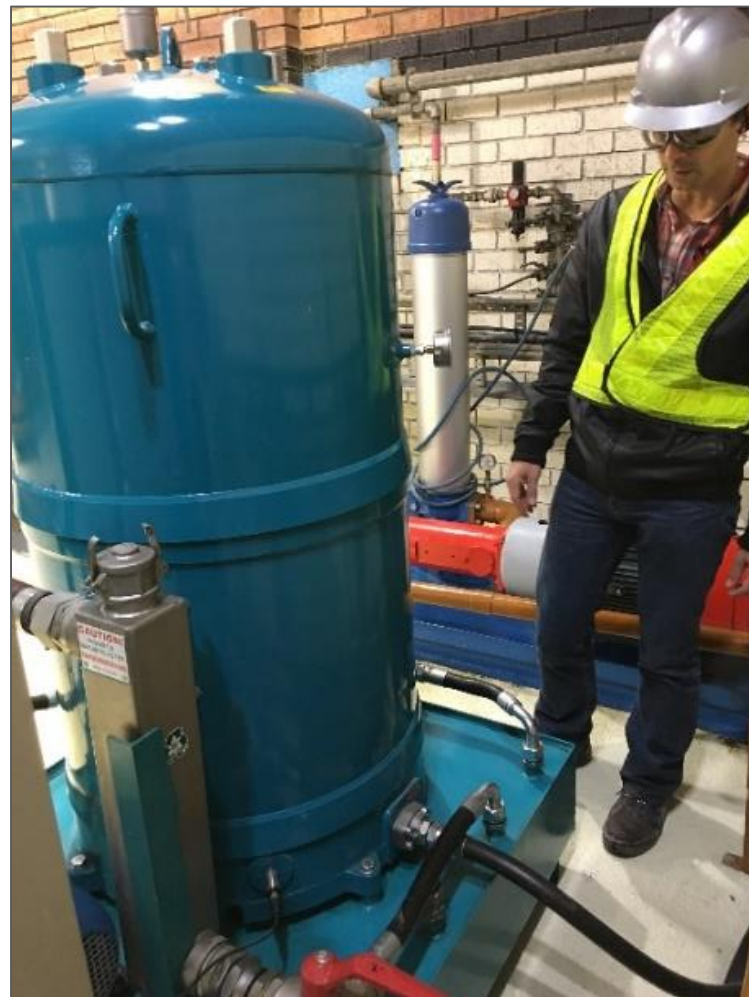
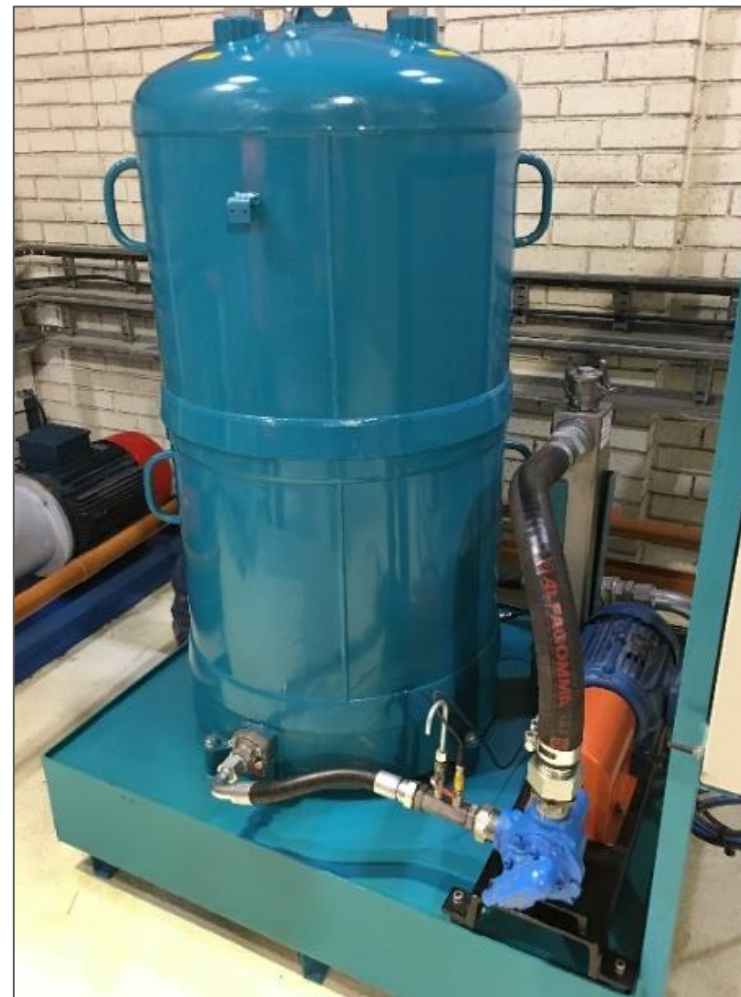
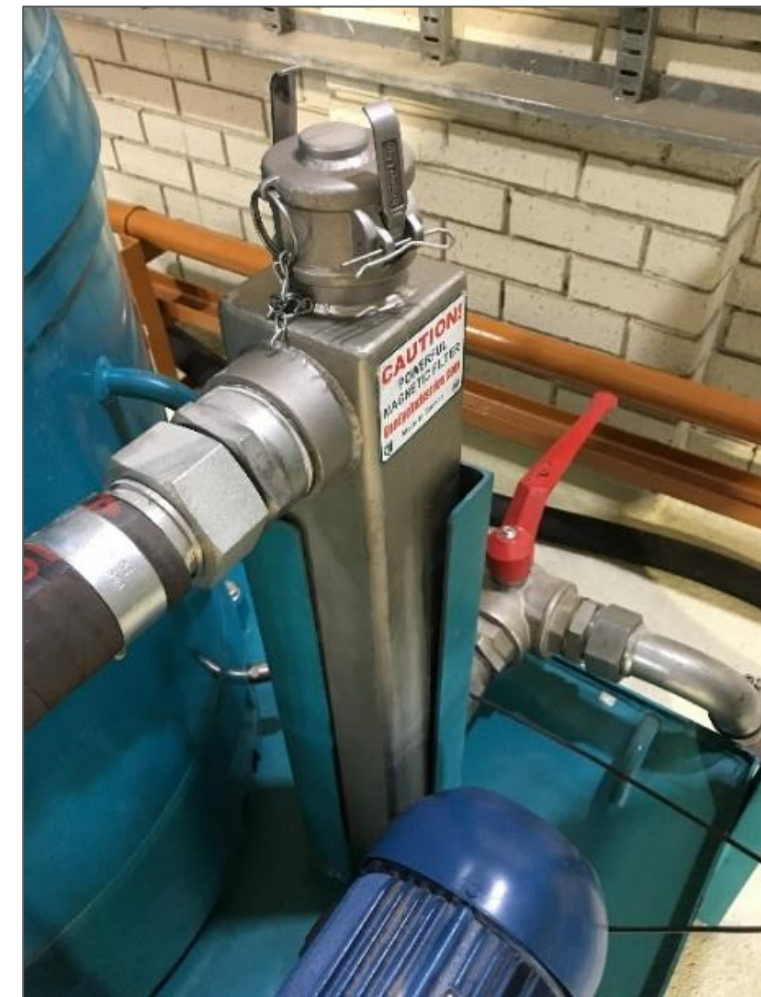
The table indicates PQ Index and spectrographic elemental analysis of the wear metals and contaminants (in parts per million) that were taken from the OEI magnetic rod and analysed in the laboratory.

PQ / Spectrometer / Wear Metals and Additives										
Sample Number	PQ	Fe	Al	Cr	Pb	Cu	Sn	Ni	Ag	Si
483204	1086	359	54	5	1	11	0	10	0	359
481019	1000	1704	168	19	3	52	0	37	0	1331
480175	1000	5129	750	123	70	347	0	258	0	2593

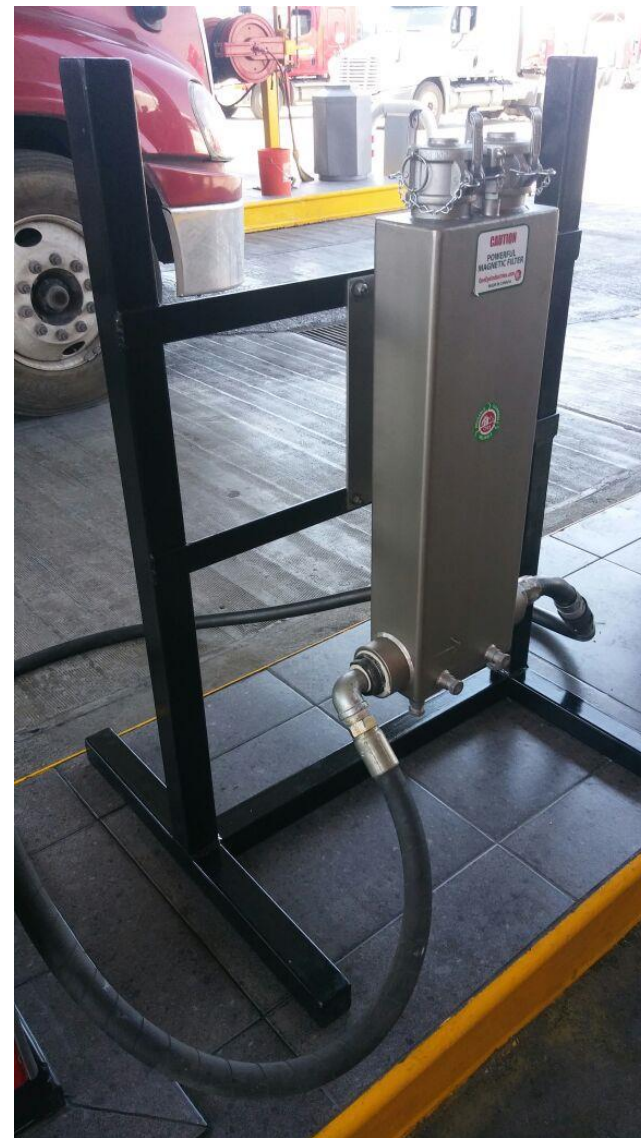
- 24" Duplex Magnetic Filter Scrubber
- 2, 1" OD Magnetic Filter Elements
- 360,000 L of diesel fuel pumped over 15 days
- Flow rate of 80 L/min
- Multiple patch tests ran to determine efficiency of OEI magnetic technology

- 15 day trial of a duplex magnetic scrubber on a new ULSD 2 diesel fuel pumping station.

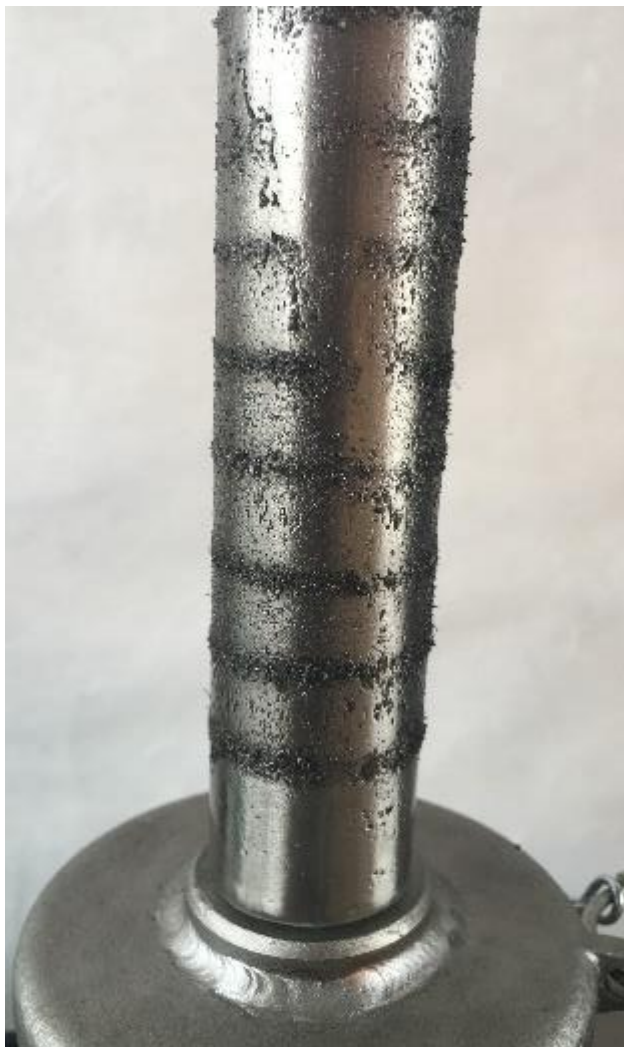
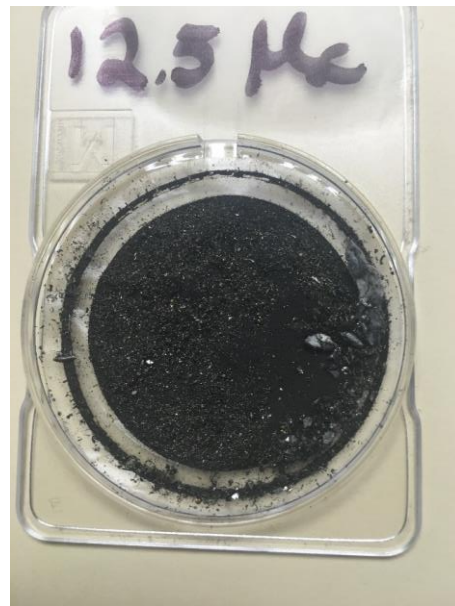
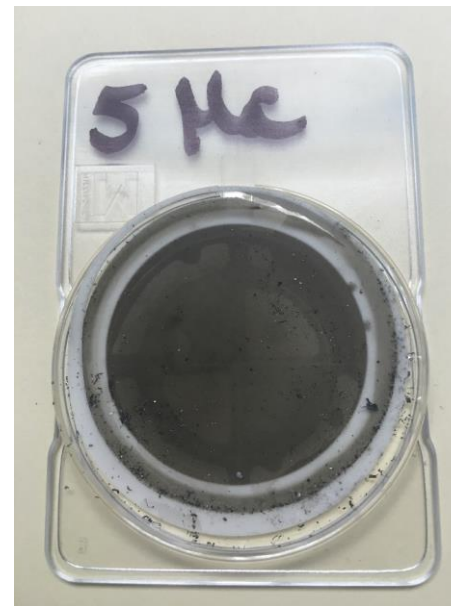
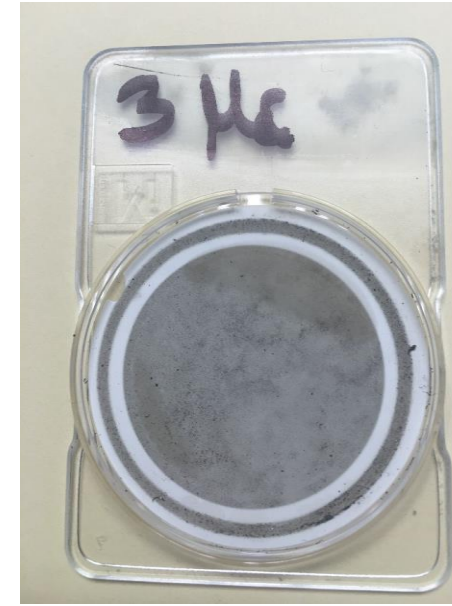
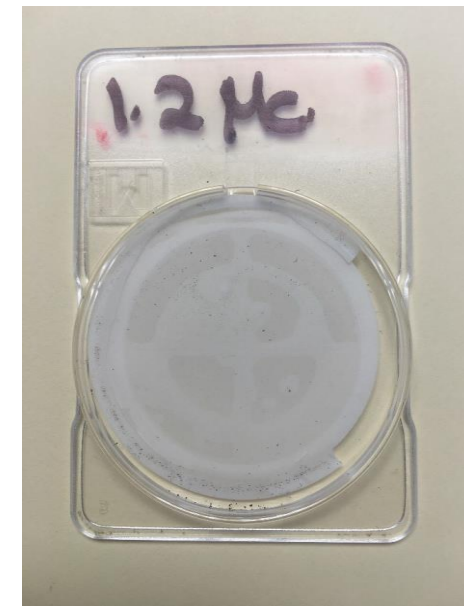
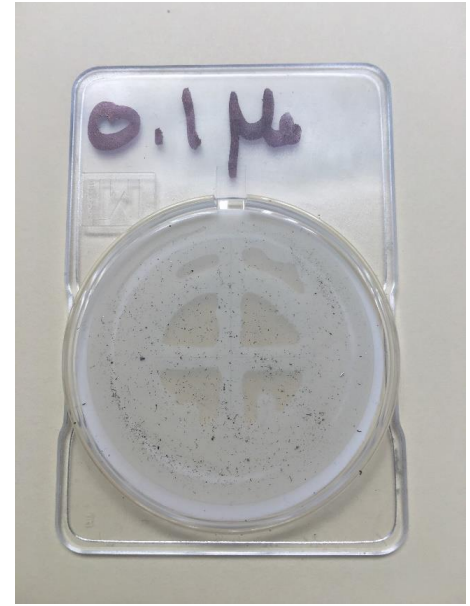
DIESEL FUEL CONTAMINATION ANALYSIS

- Millipore test results:
 - 12.5-micron particles to 0.1-micron particles

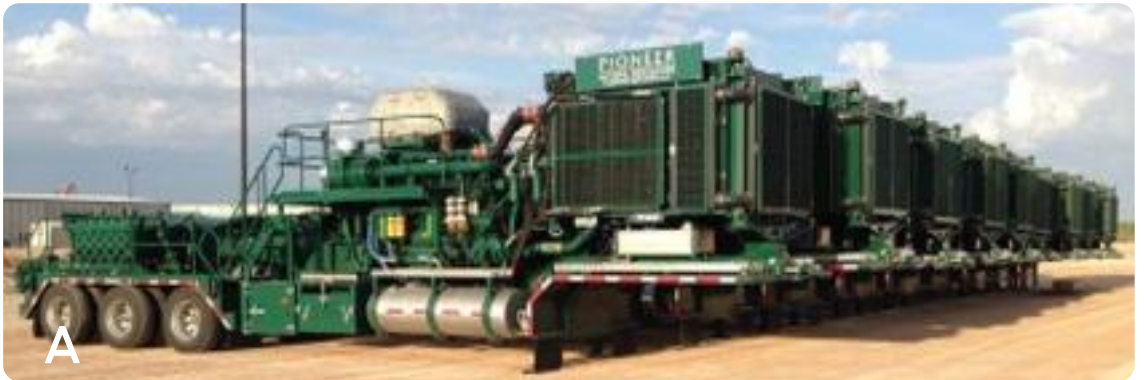
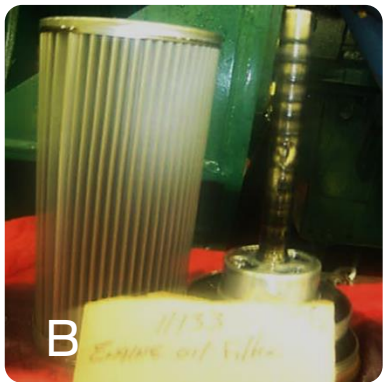
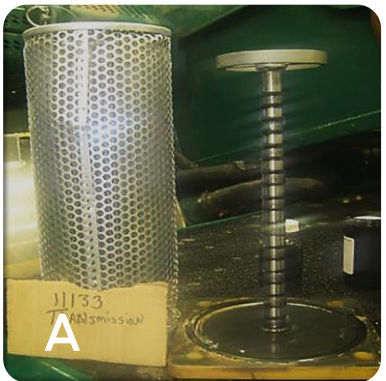
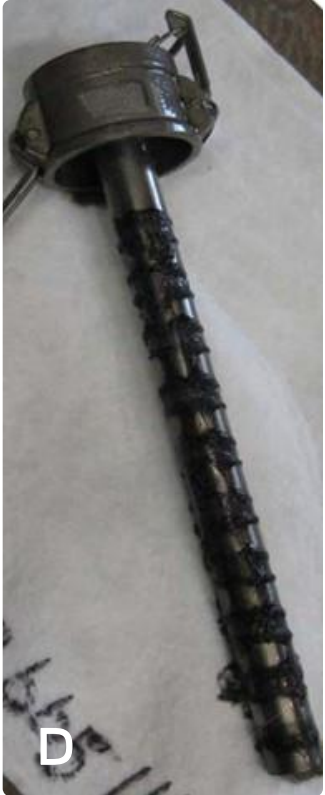
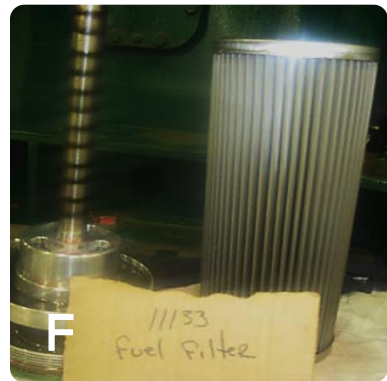
The photos show the contamination collected from multiple applications after 300 hours of operation.

MAGNETIC FILTER	PHOTO RESULT
ENGINE OIL	ADD-Vantage 9000	B
SUMP PUMP LUBE OIL	Mounted Magnetic Element	C
QUINTUPLEX PUMP LUBE OIL	Magnetic Scrubber	D
COOLANT	Magnetic Y-Strainer	E
FUEL	ADD-Vantage 9000	F

Planned maintenance intervals were extended from 250 hours to 600 hours.

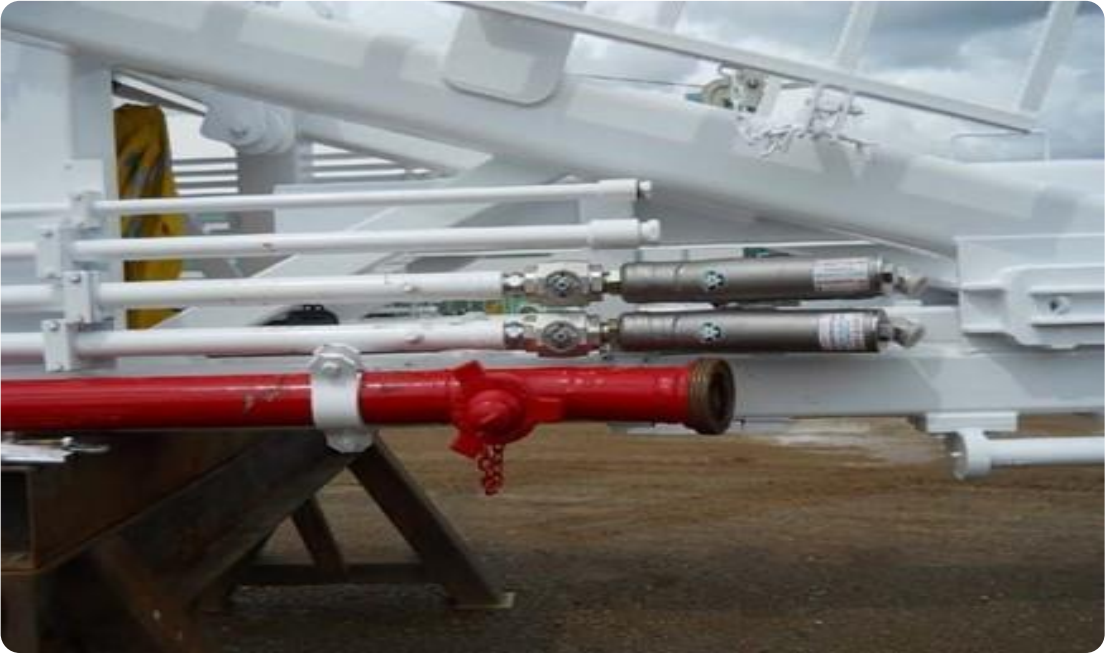
DESIGN PARAMETERS	
• >1µ FILTRATION	• SUCTION FILTRATION
• BI-DIRECTIONAL FLOW	• CLOSED-LOOP SYSTEM
• HIGH PRESSURE	• NO HORSEPOWER REQUIREMENTS

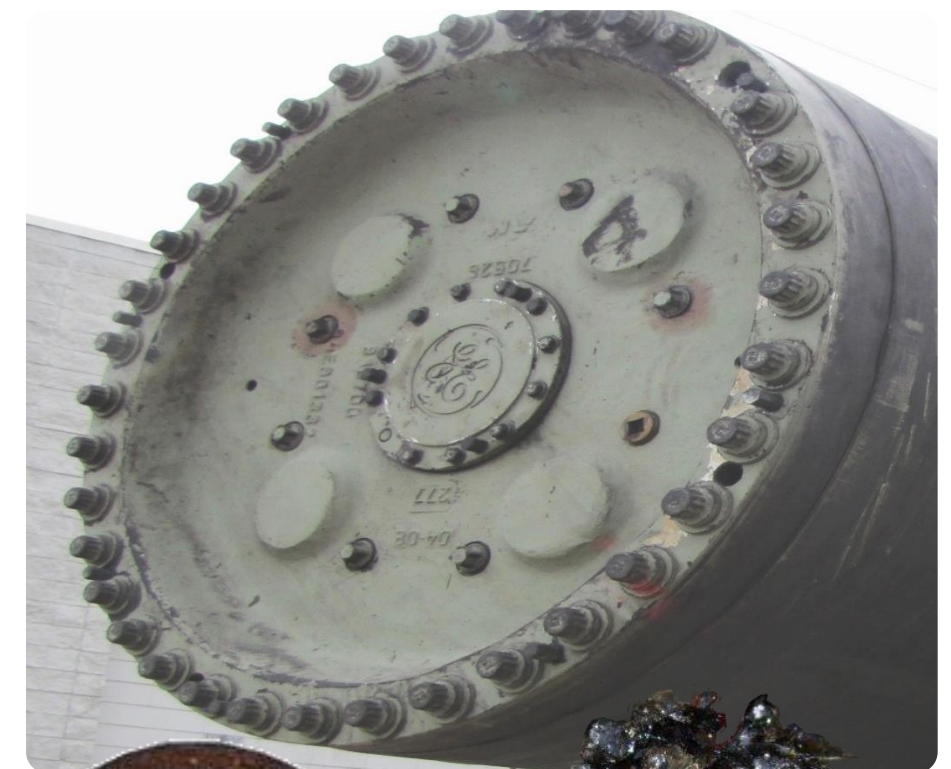
Before the test was completed, the wheel motor had a catastrophic failure.

When the magnetic plugs were removed at the rebuild shop, only the OEI Magnetic Filter Plug showed signs that a bolt had broken off causing severe damage and catastrophic failure.

If OEI Magnetic Filter Plugs had been in service and monitored as part of a predictive maintenance plan, this failure could have been prevented.

On one of the wheel motors, install 1 OEI Magnetic Filter Plug alongside 7 OEM plugs to evaluate and compare their capability of capturing wear contamination.

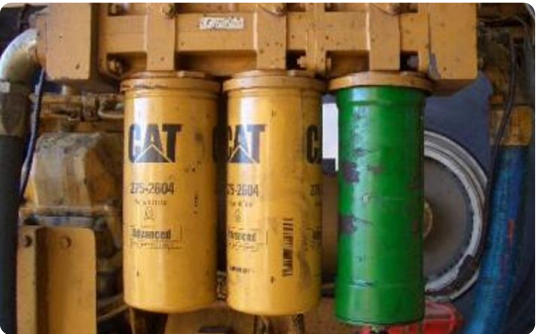
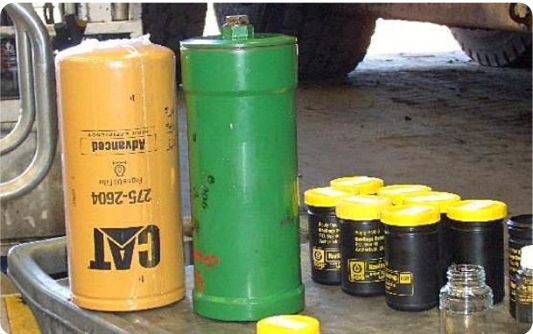
Unit Number	TKD6498														
Location	BLACKWATER MINE														
Make	KRESS														
Model	CH200C														
Serial Number	HBB-M079														
Compartment	engine-primary														
Oil Brand/Type	BP MINE MULTI 15W40														
Oil Changed	Y														
Lab Control Number										02925708					
Current Evaluation										A					
CURRENT										EVAL: A					
DAYS TAKEN TO REACH LABORATORY: 3										Wear Levels in the 5 Micron Range appear OK. Viscosity Normal for Oil Type Indicated. Infra-red analysis INVALID with oil on record at laboratory. Please supply sample of new oil to update our records. Continue Sampling at the Recommended Interval.					
DATE TAKEN	DATE REC'D	OIL ADDED	METER HRS/KM	HRS/KM ON OIL											
21-01-08	23-01-08		13980	534											
PREVIOUS #1										EVAL: A					
DAYS TAKEN TO REACH LABORATORY: 3										Wear Levels in the 5 Micron Range appear OK. InfraRed Analysis appears acceptable for Hrs/Kms. Viscosity Normal for Oil Type Indicated. All other Test Results appear Acceptable. Continue Sampling at the Recommended Interval.

DATE TAKEN	DATE REC'D	OIL ADDED	METER HRS/KM	HRS/KM ON OIL											
10-12-07	12-12-07		13446	508											
PREVIOUS #2										EVAL: B					
DAYS TAKEN TO REACH LABORATORY: 3										Iron is HIGH for the Hrs/Kms on the Oil, Lead is Increasing, Oxidation is HIGH, Oxidation result can be from Overheating/Blow By. Viscosity Normal for Oil Type Indicated. Investigate and Evaluate Compartment Condition. These results may be due to an Extended Oil Change period. REDUCE the Oil Change Interval. Resample at 250 hours.					
DATE TAKEN	DATE REC'D	OIL ADDED	METER HRS/KM	HRS/KM ON OIL											
27-11-07	29-11-07			350											
PREVIOUS #3										EVAL: A					
DAYS TAKEN TO REACH LABORATORY: 3										Wear Levels in the 5 Micron Range appear OK. InfraRed Analysis appears acceptable for Hrs/Kms. Viscosity Normal for Oil Type Indicated. All other Test Results appear Acceptable. Continue Sampling at the Recommended Interval.

DATE TAKEN	DATE REC'D	OIL ADDED	METER HRS/KM	HRS/KM ON OIL											
23-11-07	26-11-07		13186	248											
ELEMENTS:- Concentration in ppm (weight/weight)															
Wear metals															
DATE TAKEN	Cu	Fe	Cr	Pb	Al	Si	Sn	Ni	Na	K	Ca	Mg	Zn	P	W
210108	2	19	<1	2	1	3	<1	<1	3	3	2486	8	1188	1076	0.1<3.0
101207	2	19	<1	2	2	4	<1	<1	3	4	2214	7	1077	933	0.1<3.0
271107	9	46	<1	5	7	15	<1	<1	4	2	2611	9	1233	1091	0.1<3.0
231107	6	32	<1	3	6	12	<1	<1	3	2	2330	8	1116	958	<0.1<3.0
081107	3	21	<1	<1	3	7	<1	<1	3	1	2333	8	1088	988	0.1<3.0
031107	12	90	2	4	8	19	<1	<1	5	2	2650	9	1155	1000	0.1<3.0
FLUID CONDITION/CONTAMINANTS															
	ST	OXI	SUL	PQ	VSC	DEP	V100	Mo							
	41			<1	111	OK	14	<1							
	35	27	34	1	110	OK	13	1							
	59	41	49	2	110	OK	15	2							
	40	23	37	<1	111	OK	15	2							
	20	17	26	<1	106	OK	14	1							
	64			12	106	OK	14	3

With OEI filtration, the haul truck remained in service, and the CAT 3508 engine lasted an additional 17,200 hours before a glycol leak contaminated the oil and seized the engine.
