CASE STUDY

YANACOCHA GOLD MINE

CAT 24H TANDEM/BRAKE RESERVOIRS

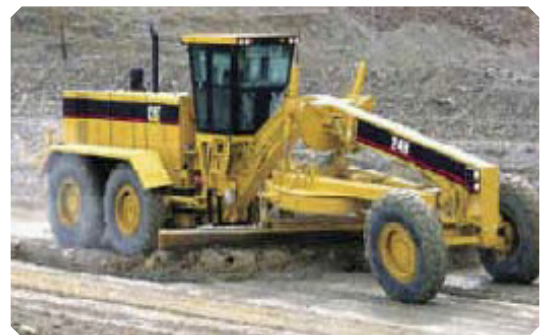
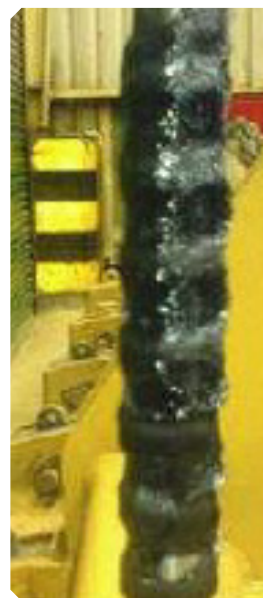
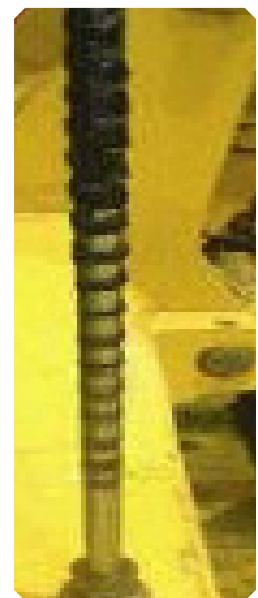
Excessive amount of metal contamination in the lube oil is the result of wear from the chain, sprocket and gears in a reservoir that has no filtration. This lube oil also acts as a coolant for the wet brakes causing premature brake disk and bearing failure.

The adjacent photos show the contamination removed from the reservoir.

Install an OEI magnetic filter element per tandem on each side. This is a simple procedure when they are installed through the inspection cover and located in the optimum splash area.
