## Magnetic Filtration Case Study

## Marion Dragline

BMA Open Cut Coal Mine  
Queensland, Australia

**APPLICATION:** No. 2 Gear Box  
DRE 38 Drag Line

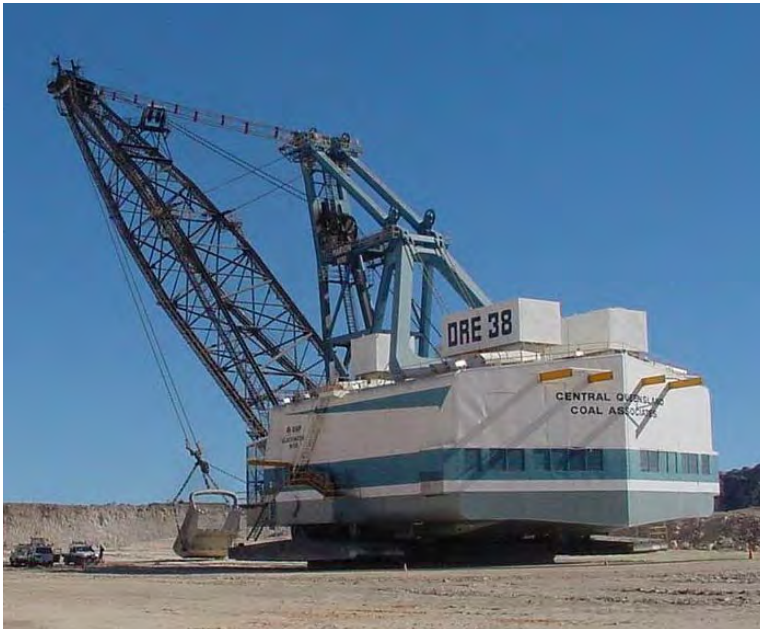
**PROBLEM:** Increasing levels of ferrous contamination.

**SOLUTION:** Install an OEI Magnetic Scrubber (5SC24SCL) to the existing kidney loop filtration system (see Photo B)
