CASE STUDY

ROLLER BEARING

GEARBOX LUBE OIL

**MAGNETIC FILTER
SCRUBBER**

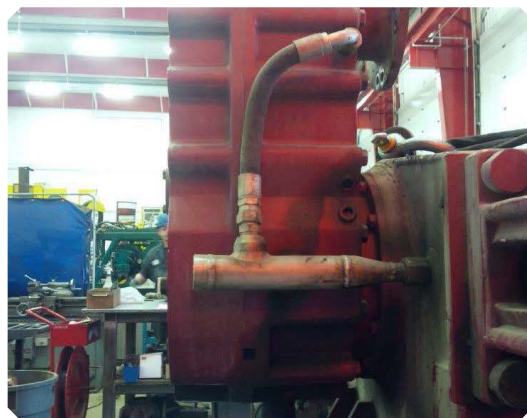
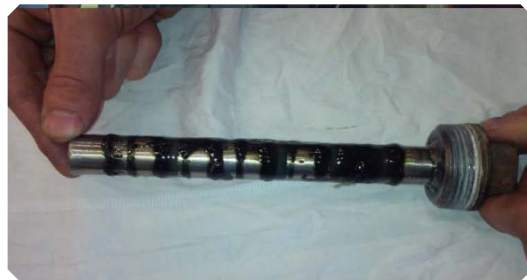
Photos show the amount of trapped contamination removed by the secondary scrubber from the system after 2 ½ years, showing that the majority of the contamination is being trapped by the primary magnetic filter.

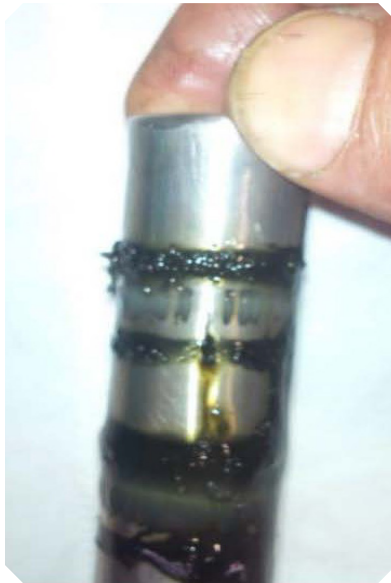
Analysis of the trapped contamination indicates that 6.88% was non-ferrous, 84.89% was ferrous and 8.23% was water. The photo at the right shows the bands of ferrous and non-ferrous contamination down to and below 3 microns.
