CASE STUDY

ALLIANCE PIPELINES

HEAT RECOVERY SYSTEMS

**HEAT
RECOVERY
SYSTEM
PROTECTED**

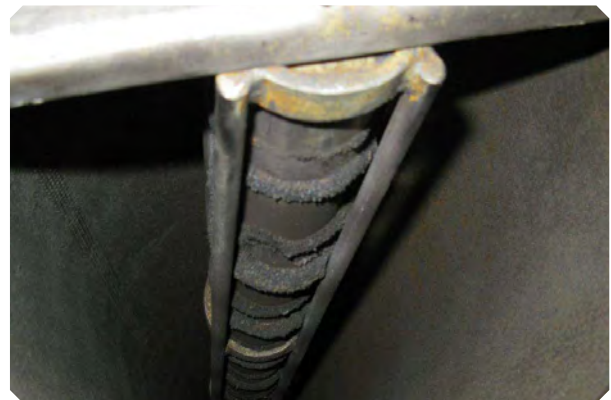
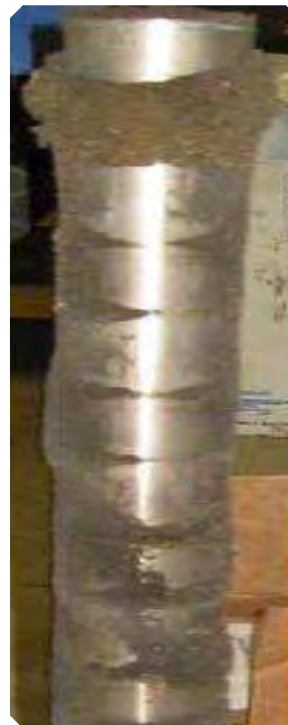
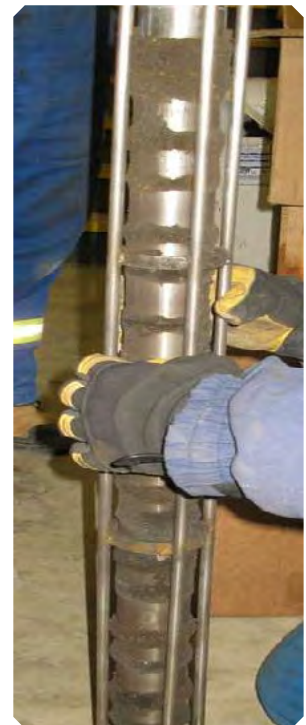
The photos show a significant amount of contamination collected on the magnetic filter elements; the pentane was cleaned, and the heat recovery system now operates far more efficient.

Install an OEI magnetic filter element inside the existing conestrainer.
