Case Study: Hydraulic Filtration March 2013

APPLICATION: Hydraulic system on Slant Drill Rig 300

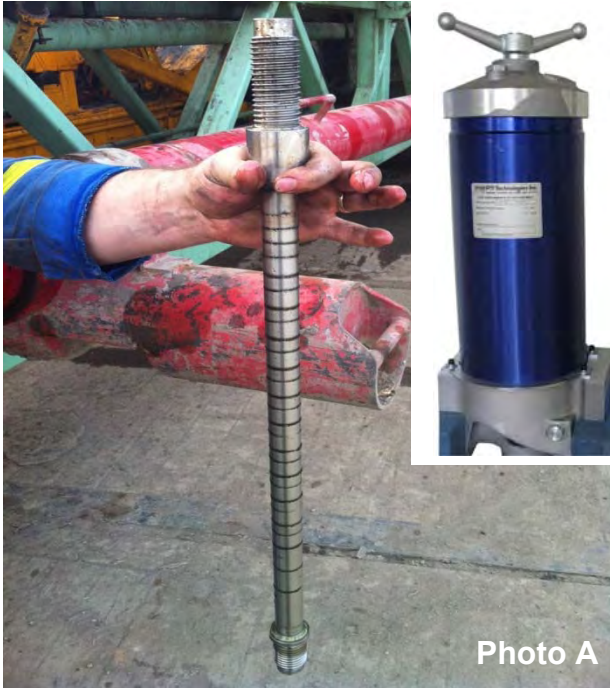
Photo A

RESULTS: "We are currently seeing the benefits of using OEI's magnetic filters through reduced particle counts during oil sampling. The sub-micron and the larger particles as seen on the magnetic filter rods in several of the pictures will undoubtedly result in reduced equipment wear. I am quite confident that hydraulic component life will be extended and that downtime due to catastrophic failure will be substantially reduced" states Brent Pavelich, Precision Drilling's Equipment and Maintenance Manager.

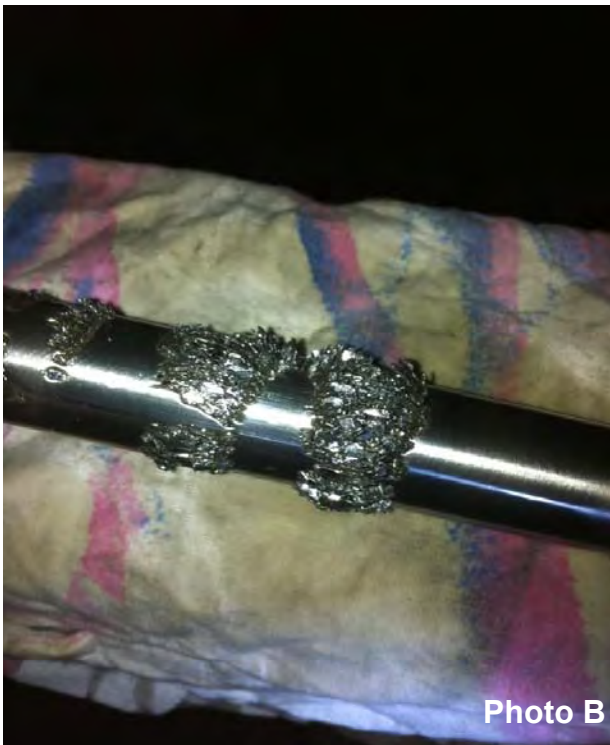
Photo B

During the 3 month test a hydraulic gear drive divider failed and the OEI filter rod trapped the metal debris (Photo B) before it could contaminate the rest of the hydraulic system and cause further component failure.

RECOMMENDATION: Install OEI magnetic filters at all possible locations on your hydraulic system to ensure protection from contamination down to sub-micron levels. For more information, contact our office at 403-242-4221 or visit our website at www.oneeyeindustries.com
