## Case Study: Lube Oil Filtration August 2012- September 2013

## STEP Energy Services Blackfalds Alberta, Canada

**APPLICATION:** Quintuplex Pump Power End Lube Oil Filtration on a Twin Pumper.

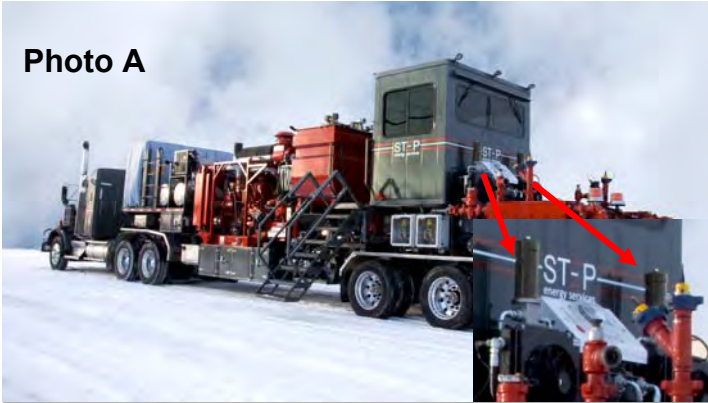
**Photo A**

**SOLUTION:** Dale Constantine, Maintenance Manager for STEP Energy Services tested and now employs OEI filtration systems as the standard for all their equipment. On this Twin Pumper Unit OEI's ADD-Vantage 9000 Dual Stage magnetic filter is installed on the power end lube oil system (Photo A) to remove the contamination under 10 microns.

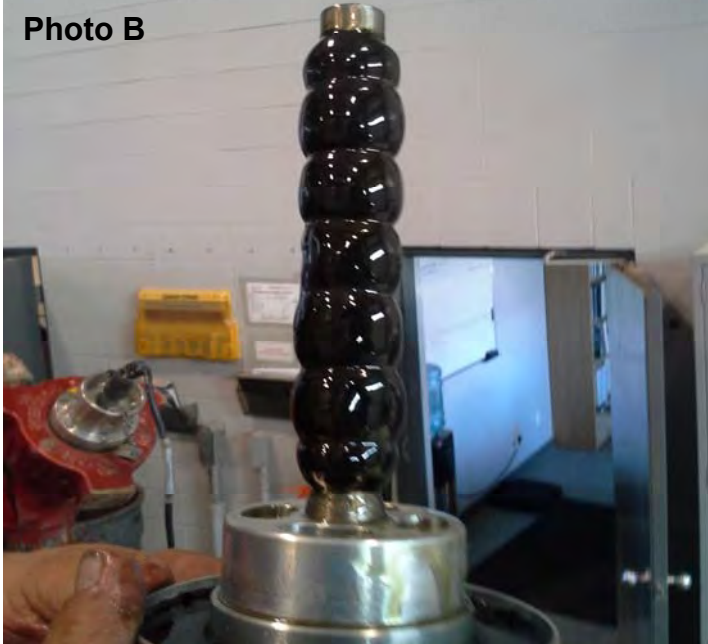
**Photo B**

**RESULTS:** Photo B shows the tremendous amount of trapped contamination removed by the two stage magnetic filter during their yearly PM. STEP Energy Services analyzed the contamination and found that it contained a large amount of both ferrous and non-ferrous particles from 30 microns down to sub-micron levels (Photo C).

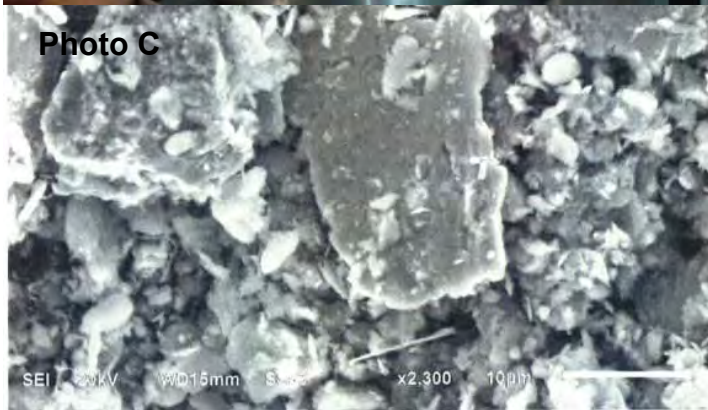
**Photo C**

The analysis conducted on the contamination identified that over 50% was iron oxide, 40% non ferrous and 7% water. The majority of the particles were found to be less than 10 micron" in size (Page 2). OEI magnetic filtration systems have become a significant "part of the solution" in improving STEP Energy Services' maintenance program. By reducing downtime and operational costs STEP Energy Services is enjoying a high level of equipment reliability in their industry.
