CASE STUDY

LINAMAR PLANT

HOTSY PARTS WASH STATION

PARTS WASHER FLUID

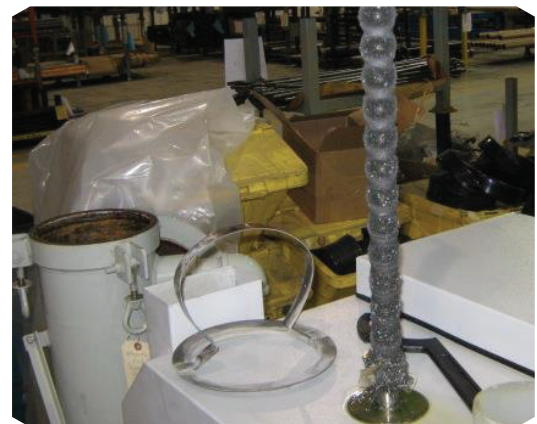
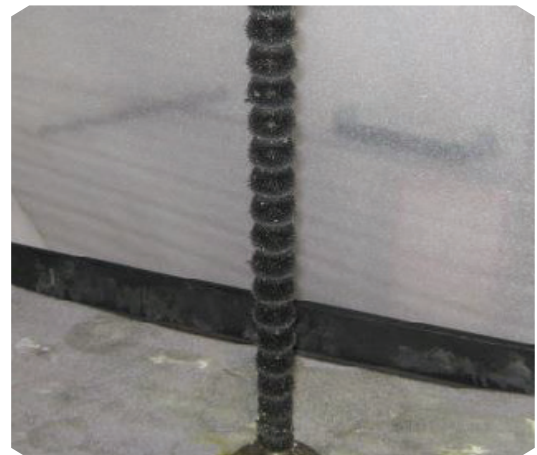
The photos show contamination captured after 8 days in operation; the system operated for 8 hours per day. Due to the significant amount of contamination captured, a secondary washer was not required, resulting in a considerable cost savings for the company. The OEI magnetic filter is still employed in this application and achieving cleanliness levels beyond specifications.

Enhance the present filtration system by installing an OEI magnetic filter element in the filter bag to remove all ferrous contamination to sub-micron levels.

Shortly after installing the OEI magnetic filter rod, the cleanliness level required was achieved and surpassed. The magnetic filter was able to trap contamination to sub-micron levels.
