OROGEL: FOOD PROCESSING FACILITY	PROVEN	EXTENDED
LOCATION	RESULTS	OPERATING LIFE OF
FC, ITALY / FEB 2007	RESOLIS	COMPRESSORS
EQUIPMENT	all a	RESULTING
AMMONIA COMPRESSORS		IN LOWER MAINTENANCE
APPLICATION		AND EQUIPMENT
LUBE OIL		REPLACEMENT COSTS
	ζ

MAGNETIC FILTER ELEMENT

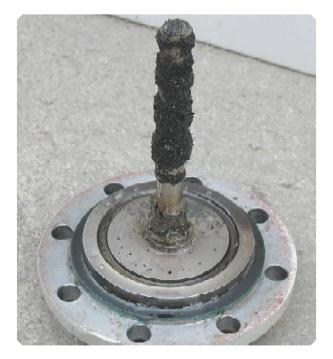
The photos show contamination captured after the 4th cleaning of one compressor with 352 hours of run time.

The OEI magnetic filter element proved to protect the compressor by capturing significant amounts of wear contamination missed by the existing filter.
