CASE STUDY

ORTO VERDE: FROZEN FOOD PACKAGING PLANT

AMMONIA COMPRESSORS

LUBE OIL

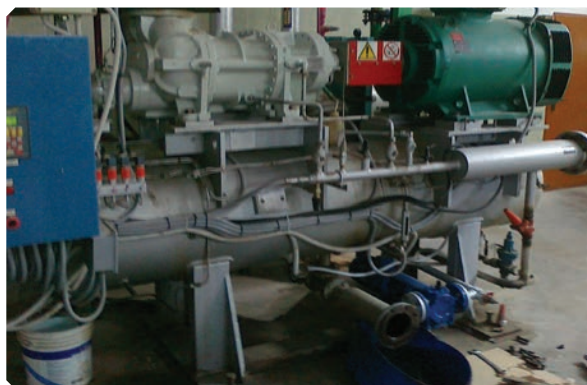
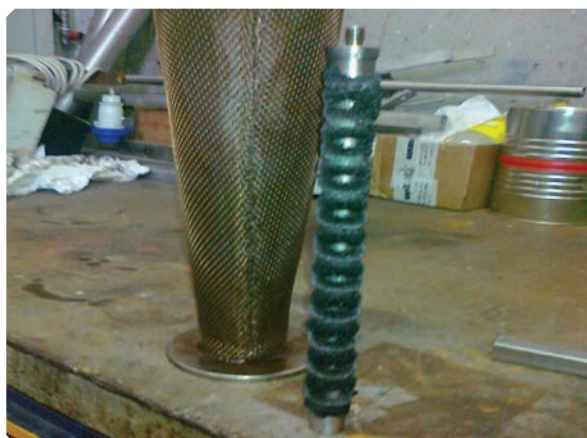
Improve the operational life and prevent frequent failures of an ammonia compressor by capturing the wear contamination that was causing filter clogging, premature wear of compressor components, and early oil change-outs.

The photos show significant amounts of contamination captured after 1800 hours of operation.

Test for the volume of wear contamination in the lube oil system; install an OEI magnetic filter element in the existing cone strainer employed on the compressor pump's pre-filter lube oil system.

Impressed with the test results, the facility maintenance manager installed OEI filters on all plant compressor lube oil systems; he then conducted magnetic filter testing on ammonia lines to further improve the reliability of facility compressors.
