## CASE STUDY

ENI DRILLING COMPANY

OFFSHORE GAS PLATFORM

GLYCOL DEHYDRATION

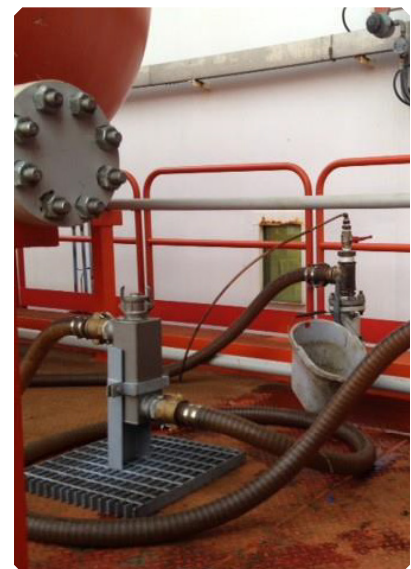
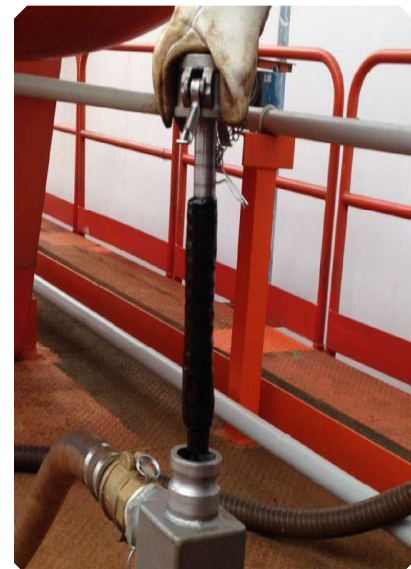
Analysis of contamination collected on the magnetic element showed 74% non-ferrous particles and 26% ferrous.

SPECTROSCOPIC ANALYSIS	
Iron	606 ppm
Chrome	17 ppm
Nickle	< 5 ppm
Manganese	12 ppm
Aluminum	93 ppm
Lead	< 5 ppm
Copper	24 ppm
Tin	< 5 ppm
Silver	< 5 ppm
Titanium	5 ppm
Silica	410 ppm
Sodium	26 ppm
Potassium	130 ppm
Vanadium	< 5 ppm
Calcium	14 ppm
Magnesium	64 ppm
Phosphorous	779 ppm
Zinc	30 ppm
Barium	86 ppm
