Esso Has Weatherford-Ampscot Install Magnetic Filter Rods in Pump jack Gear Boxes at the Factory

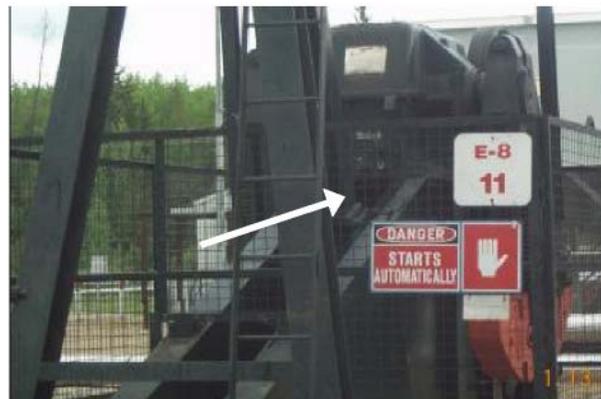
Trial magnetic filter rod location in gear box of a LeGrand 160. (Arrow indicates gear box.)

FilterMaster 2000 & 3000 Magnetic Filter Rods were introduced and tested on 6 pump jacks (E-8: 1, 6, 11, 12, 13, 19). All 6 of the test rods were installed on June 15, 2003 on LeGrand 160 pump jacks and were to be removed and evaluated for effectiveness 37 days later.

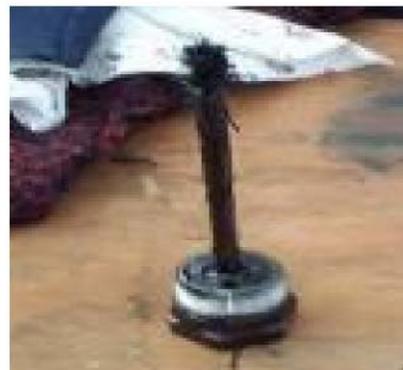
Above: The original magnetic rod in service for about 8 years.

Before the test, the original factory installed magnetic rod which had been in service for about 8 years, was removed from the gear box for the first time. It had never been cleaned and had about 1/8" of ferrous material on it. The rod had a Gauss rating (the scientific measure of the magnetic strength) of about 350.

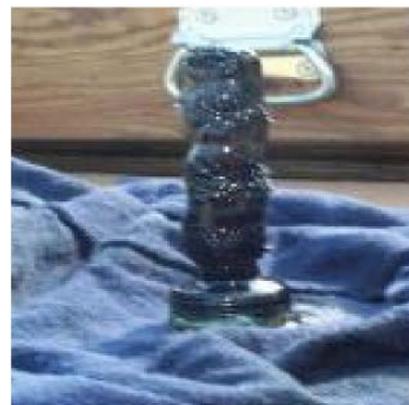
Below: The FilterMaster 2000 Series Magnetic Filter Rod, in service on the same gear box for only 37 days.

After 37 days of normal operation the FilterMaster 2000 Series Magnetic Filter Rod (with a Gauss rating of about 12,000) was removed. It was covered by ferrous material a 1/2" thick.
