CASE STUDY

BHP, BILLITON MITSUBISHI ALLIANCE

BLACKWATER QUEENSLAND, AUSTRALIA / JUL 2008

HAUL TRUCK

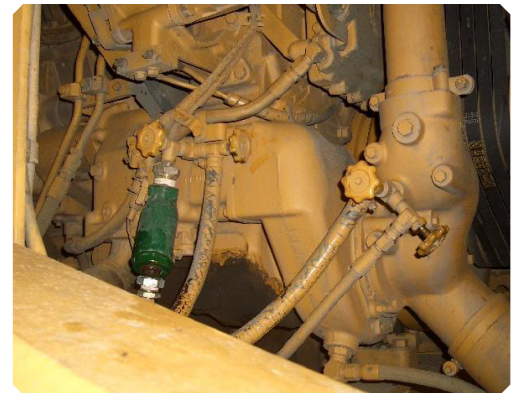
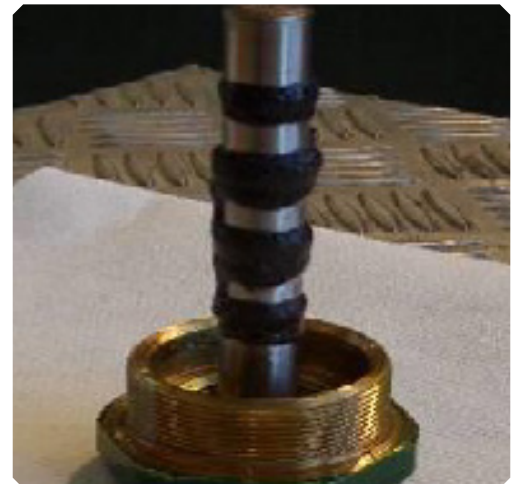
After 500 hours of engine operation, the OEI magnetic filter was removed revealing a substantial amount of ferrous metal that had been extracted from the coolant fluid. If left circulating in the coolant fluid, these metal particles will prematurely wear out cooling system components such as the water pump, radiator and seals in addition to degrading the fluid.

Install an OEI magnetic Y-Strainer on a secondary coolant line.
