CASE STUDY

GUN POWDER MANUFACTURER

PROCESS WATER SYSTEM

PRODUCT RECOMMENDATION
ADD-VANTAGE 9000 VS STAINLESS STEEL FILTER SKID

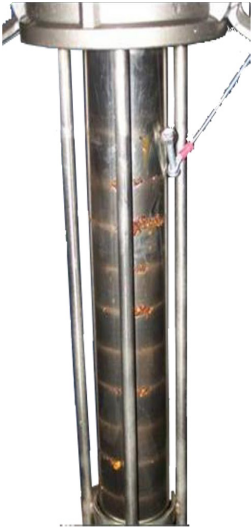
CONTAMINATION CAPTURED BY THE MAGNETIC FILTER ELEMENT

The photos show contamination collected after 2 weeks of operation. The lead Process Chemical Engineer determined the test successful because the facility water now meets municipal water quality standards. The company has since installed multiple OEI filters throughout the facility.

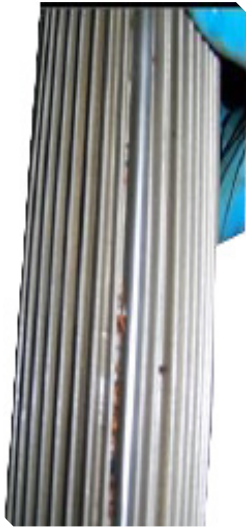
CONTAMINANTS CAPTURED BY THE STAINLESS-STEEL CLOTH ELEMENT
