CASE STUDY

IRON ORE COMPANY OF CANADA

830E HAUL TRUCK WHEEL MOTOR

UNIQUE DESIGN
ALLOWED TO
SOLVE PROBLEM OF
CONTAMINATION

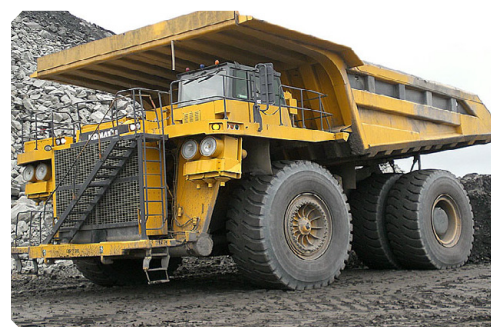
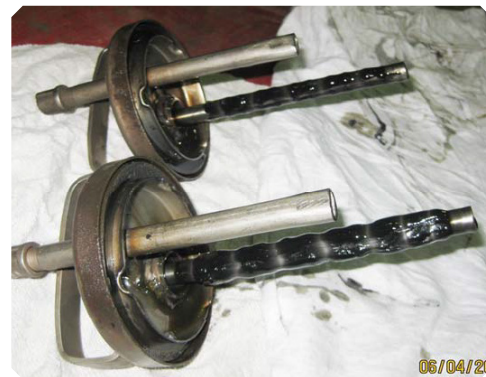
The photos show contamination captured on the magnetic filter elements after 450 hours of operation.

Replace the OEM filler cap with a specialty OEI magnetic filter filler cap designed with a filter dipstick to capture contamination in the system, and a sample port to prevent external contamination from entering the system during fluid level inspections.

- Fluid levels can be checked without removing the filler cap
- Oil can be sampled by inserting the hose into the dip stick pipe which stops the hose at a predetermined length for consistency
- The magnetic filter element can be removed and the contamination analyzed to determine premature component wear
