## CASE STUDY

NEWCREST MINING LTD

CRACOW GOLD MINE / MAY 2008

CONE CRUSHER

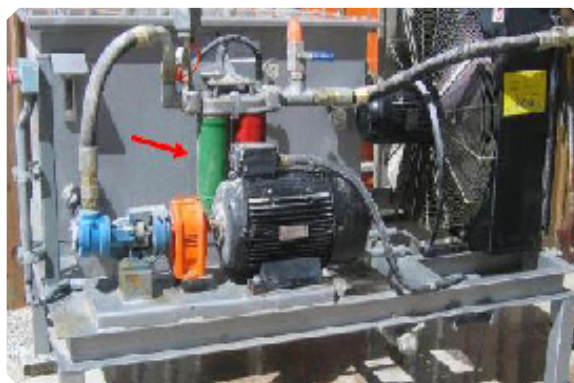
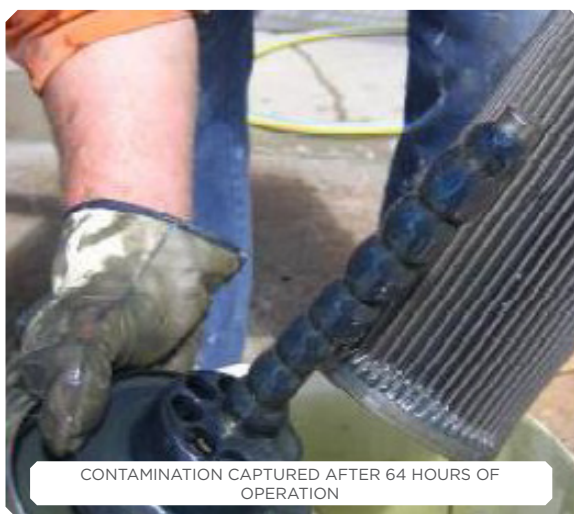
CONTAMINATION CAPTURED AFTER 64 HOURS OF OPERATION

After 64 hours a substantial amount of ferrous contamination was extracted and trapped on the OEI magnetic filter. If left in the fluid these metal particles will prematurely wear the components and degrade the fluid viscosity.
