CASE STUDY

PRECISION DRILLING

HYDRAULIC SYSTEM ON SLANT DRILL RIG 300

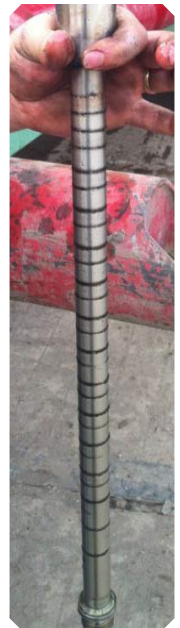
PRODUCT
RECOMMENDATION
**MAGNETIC FILTER
ELEMENT**

Replace the OEM PTI filter with an OEI magnetic filter element in order to remove this contamination down to submicron levels.

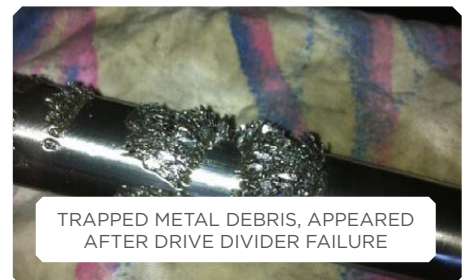
TRAPPED METAL DEBRIS, APPEARED
AFTER DRIVE DIVIDER FAILURE

During the 3 month test a hydraulic gear drive divider failed and the OEI filter element trapped the metal debris before it could contaminate the rest of the hydraulic system and cause further component failure.
