CASE STUDY

SUREFIRE INDUSTRIES

N-2 PUMPER

HYDRAULIC & GLYCOL COOLANT

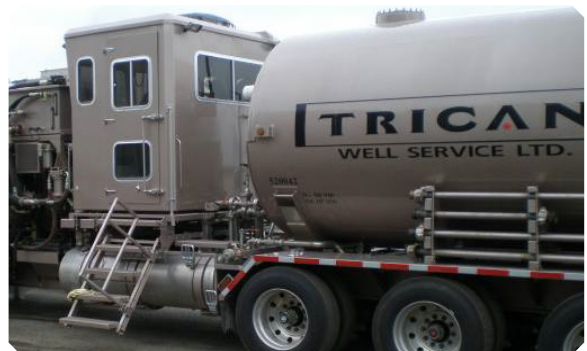
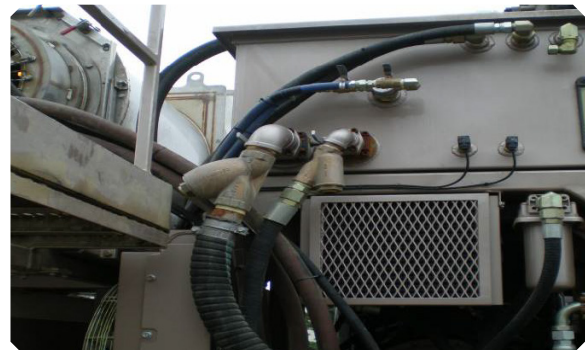
Ferrous contamination from manufacturing process.

OEI filters installed on the hydraulic reservoir on an N-2 Pumper for Trican Well Service Ltd of Red Deer. After 3 months of operation, the photo clearly displays a significant amount of ferrous contamination. The unit's traditional filtration failed to remove the contamination that would have caused serious premature wear to the pumps and seals of the hydraulic system.

Install OEI inline magnetic filter y-strainers on the hydraulic and glycol lines prior to the pumps as directed by senior design engineer Oleg Tsvik.
